LITTLE OUSE HEADWATERS PROJECT

DRAINAGE AND SOILS STUDY

ADAMS LAND MANAGEMENT LTD

May 2, 2014
Authored by: Andrew Adams

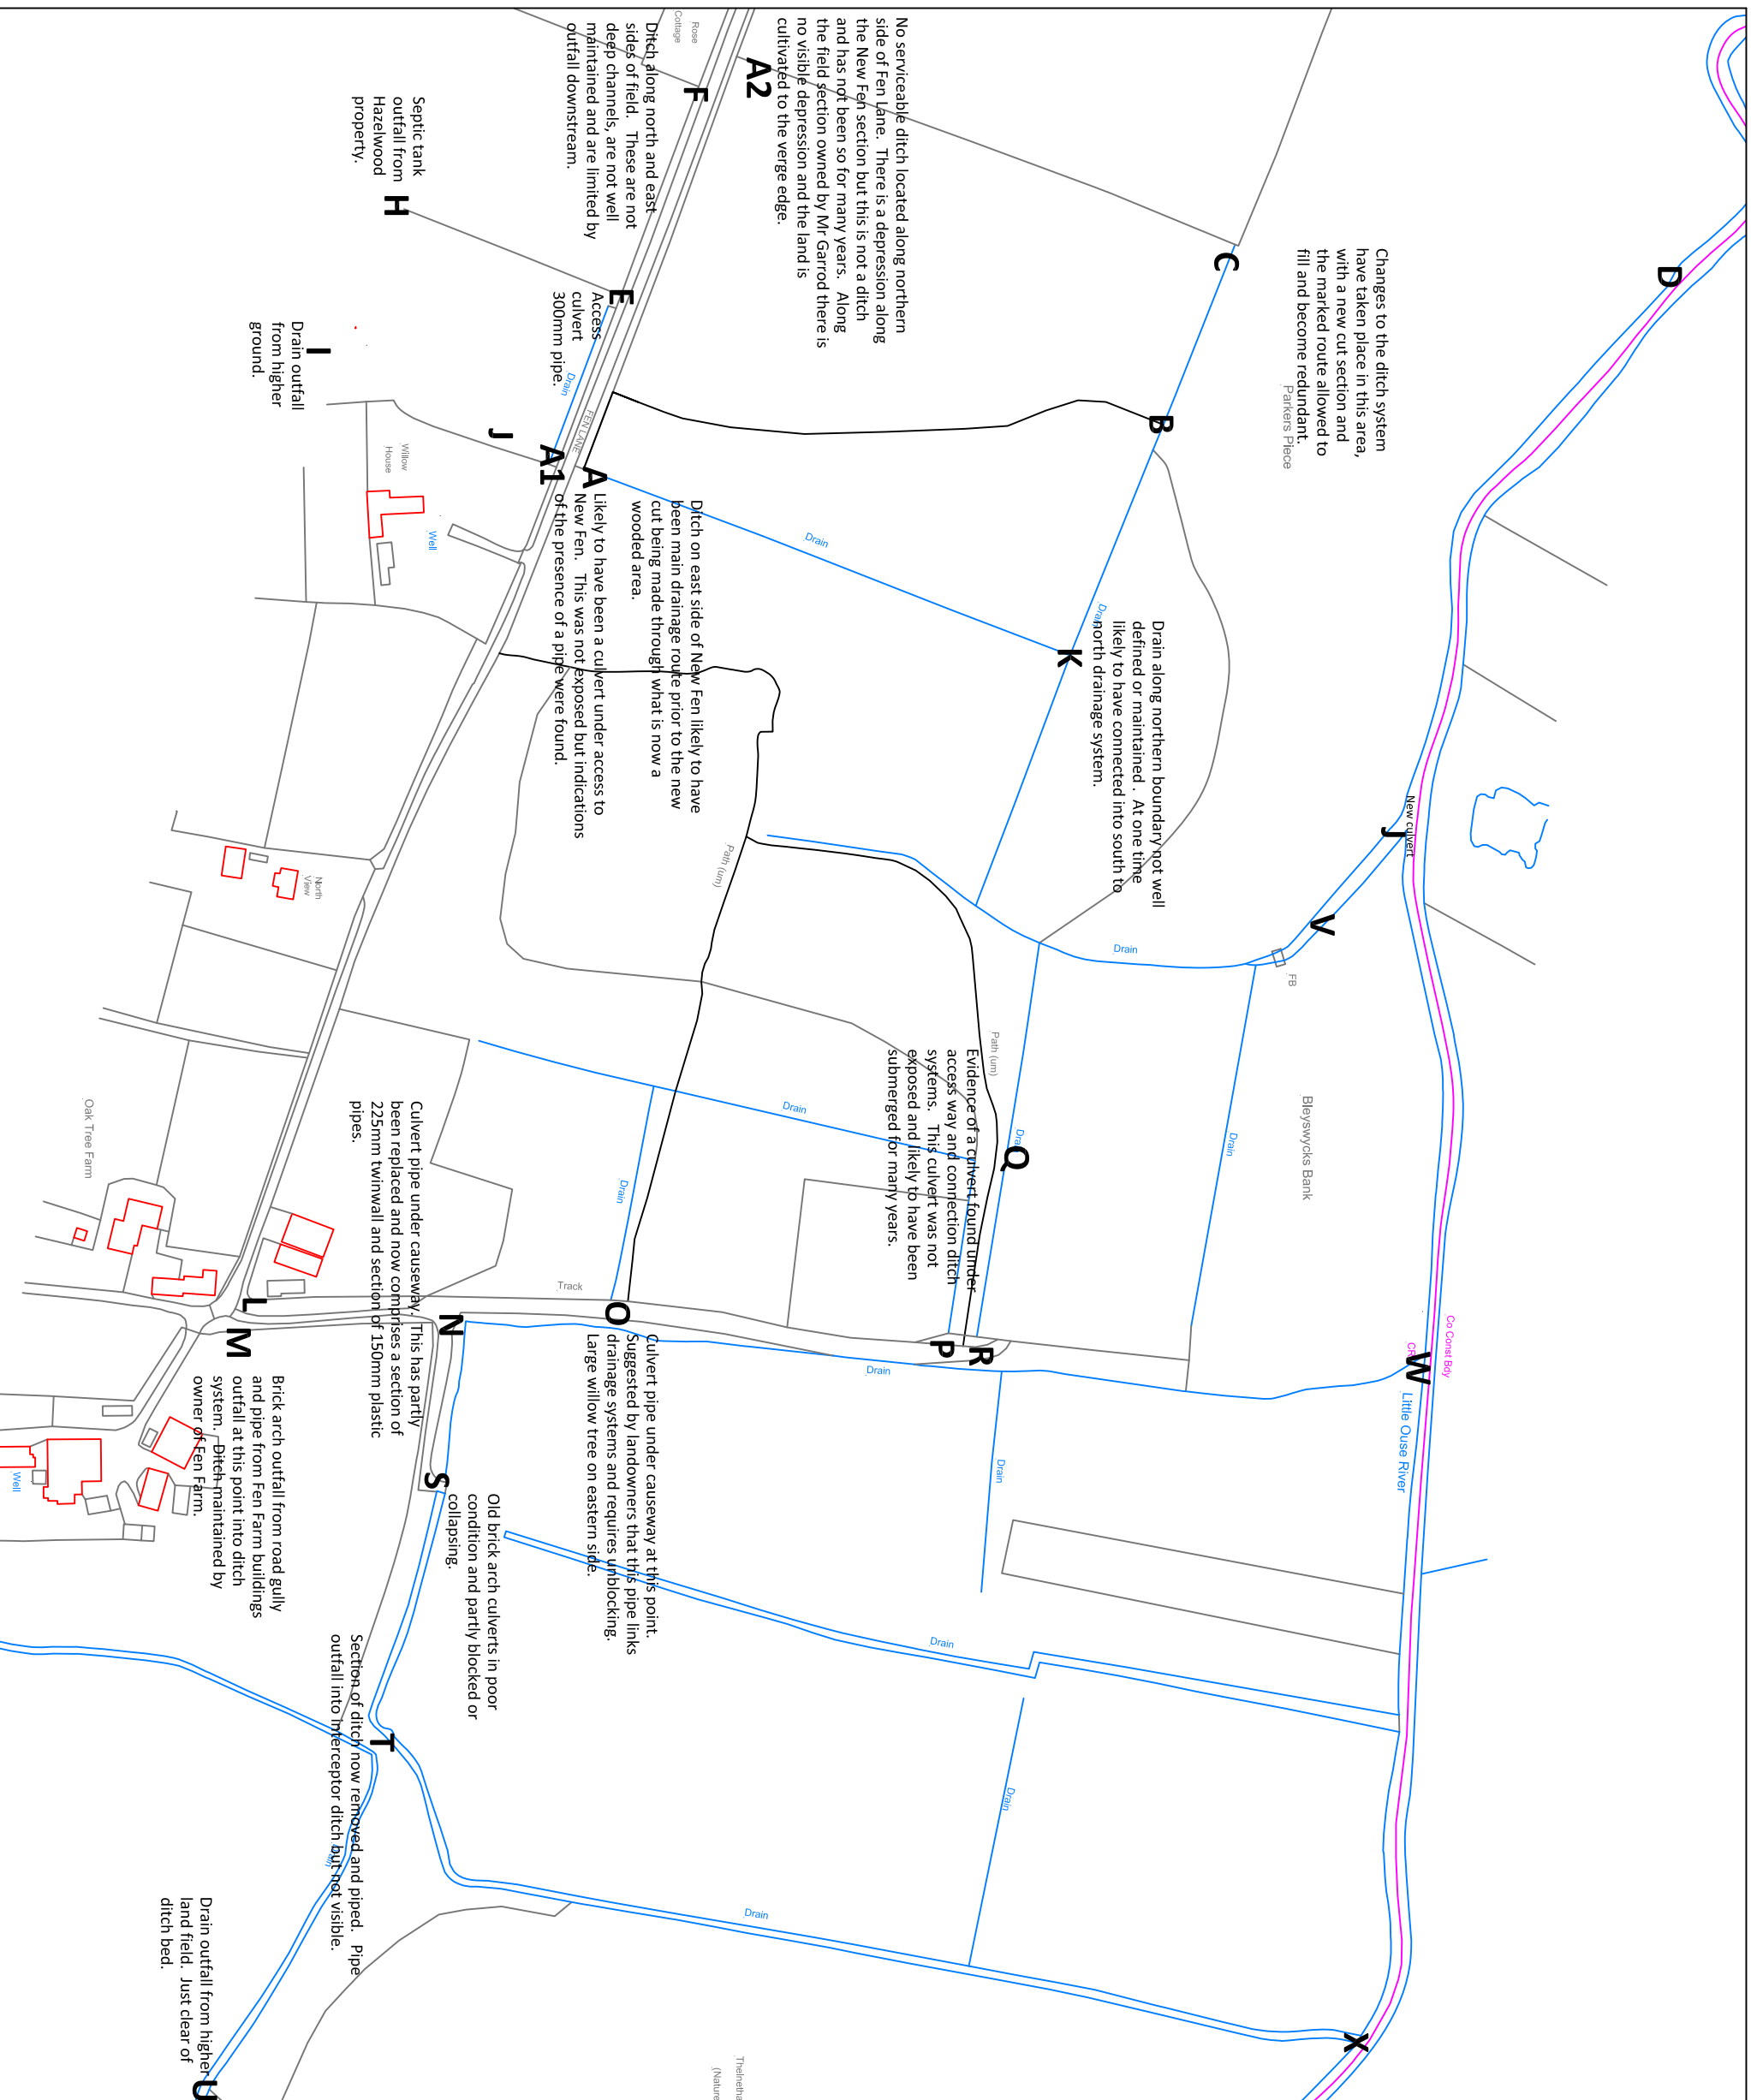
Appendix 2

Section	Description	Comment
A1 -A	Clay pipe culvert under Fen Road. Inlet and outlet clear but water builds up to submerge outlet and this has an impact on upstream flows.	Improvements to the downstream system will give benefit, but based on existing land use and drainage requirements, it would be possible to manage water levels and risk to meet all requirements through water control and some ditching works.
A - D	This is the ditch system between Fen Lane and the Little Ouse River and includes new cut sections. A longitudinal section is included at Appendix 5 to this report which highlights that a fall is possible between A and D but there are hold ups within the system.	The longitudinal section illustrates that with some improvement, especially at point C and between C and D, a flow could be achieved. Point C could also be used as a control structure point if water level control was required.

E	Culvert under entrance to Fen Cottage.	Culvert appears reasonably clear but evidence of polluted material within the ditch was noted. The culvert depth and the invert level relative to land level indicates that there is little opportunity for improvement unless significant work was carried out downstream and this would be new work and not replacing existing.
E – A1	Ditch section along northern boundary of Hazeldene.	Ditch in average condition and would benefit from improvement which would assist in storage and more efficient flow. Sluggish ditch has benefits in maintaining polluted material within the system.
E – F	Ditch section on northern boundary of field owned by Mr Garrod. A small ditch which depends on points E and A1 for outfall.	No obvious land drains outfall into this ditch and opportunity for improvement is limited by culvert at Hazeldene and not levels downstream.
F	Access culvert to field.	Culvert not visible and, from appearance, not maintained for many years. Could take water from Water Lane Farm and Rose Cottage but not well maintained to allow free flow or to suggest that hold ups downstream are limiting the functioning of the system.

H	Septic tank outfall from Hazeldene.	Direct outfall into ditch system.
I	Land drain outfall.	Drain outfall from land to the south within the ownership of Messrs Orford of Fersfield. Drain clear of ditch bed and running at the time of inspection. (4 th March 2014)
J	Outfall from new waste treatment unit.	Although discharging directly into the ditch, water appeared clean. Test results would confirm water quality from this outfall.
A – A2	Ditch along southern boundary of New Fen.	Ditch more a depression than a defined ditch and it could be argued that it has always been in this condition, at a lower level than Fen Lane. There are indications, however, which suggest it has served a drainage function with a culvert access into the wooded area. The land falls from A2 to A.
A2 – A3	No ditch visible with land cultivated to narrow road verge.	Possible that a ditch extended from A2 to A3 in the past but this has been filled. There is also a possibility that a culvert exists across Fen Lane between points B and E, flowing into a former ditch. This, however, cannot be confirmed without further investigation.

A – K	Ditch section which has become silted or has been filled.	This ditch, which borders Middle Fen, was at one time the main carrier ditch from the culvert at point A. The carrier function of the ditch has largely been replaced by the section A –D and this route may be preferred. There is a culvert at the head of the ditch and some bunding has occurred, the function of which is uncertain, but it appears as a result of the creation of a scrape area on the eastern side of the ditch. Ditches within the Middle Fen area, although visible, have been allowed, presumably through design, to silt up and therefore serve little drainage function.
L	Brick culvert, being the outfall from the grating at the junction of Fen Lane and Loggers Lane.	This culvert is not in good condition and is located well into the ditch bank and enclosed by vegetation. The culvert does function, albeit probably not very effectively, and the open grating represents the only provision for surface water drainage from Loggers Lane. This Lane is quite steeply sloping with high banks and, therefore, in times of high rainfall, high flows are directed to the single grating. Inevitably the drainage system overtops and some flooding and overtopping into the causeway and ditch system will occur. Surface water flows from Oak Tree Farm and Fen Farm also contribute to the flow capacity. This outfall is likely to be a source of high silt volumes within the ditch system and this is confirmed by evidence of cleansing of the ditch and the views of Mr Webb.

M	Outfall from Fen Farm Buildings.	The actual source of this pipe is not known, but it is likely to be the yards and buildings of Fen Farm. The pipe is below the ditch bed but evidence of flow was noted and the ditch is maintained. Fen Farm has previously been a pig unit but now ducks are kept within the buildings. Runoff from the yards and buildings

into the pipe is likely to be polluted and some evidence of this is clearly visible in the ditch M – N.
N	Sections of 225mm twinwall and 150mm plastic pipe.	The invert of the inlet into the twinwall pipe is at ditch bed level. There is some silt build up but flow is occurring. The junction between the 225mm and 150mm pipes is not visible and so the condition cannot be reported upon. There is a fall between the inverts of the inlet and outlet pipes and the preferred flow direction appears to be towards point O, although towards point S would also be possible.
N – O - R	Ditch section.	<p>This is a ditch section on the eastern side of the causeway. There appears some disagreement about ownership and past management of the ditch. Mr Green is adamant the ditch is not his and that Mr Webb has maintained it for many years whilst in his ownership. Mr Webb has confirmed this. LOHP now own the land to the east but do not consider the ditch to be within their responsibility. There appears to be no local custom for the management of ditches. Such customs, which are common in many fen or marsh areas, might include:</p> <ul style="list-style-type: none"> • Responsibility runs with the landowner on the left or right of the ditch and this follows throughout the area. • The boundary runs along the centre line and each adjoining landowner, therefore, has joint responsibility with maintenance shared. <p>The ditch is not in good drainage condition with several willow trees blocking flow and no evidence of maintenance in the recent past.</p>

O	Culvert under the causeway taking water from Mr Green’s land to the west.	<p>An open pipe and evidence of clearance was visible but no outfall was found into the ditch on the eastern side. A mature willow tree is located at the likely outfall point of the pipe and so any effective outfall is doubtful - a situation that has likely to have been so, or a high risk of being so, for many years.</p> <p>The ditch systems on the western side of the causeway are not well maintained. Whether this is by design or because of outfall limitation is difficult to give a categorical opinion. It is clear, however, that the ditch systems within this are require an outfall and this could be at points O, R or P, all of which appear to be blocked.</p>
P	Possible culvert under causeway as for point O.	No pipe visible and any outfall in to the eastern ditch is restricted.
Q	Possible culvert under access.	Possible link for drainage system and some evidence of a pipe was located. It is clear that any pipe has been silted and below ditch levels for many years. The east –west ditch on the northern side of the access in this location is in poor drainage condition, again a situation that is unlikely to have changed for many years and influenced by the management of Middle Fen and other associated ditches.

R	Possible culvert under causeway as for points O and P.	No culvert pipe located, but possibly in place historically to provide ditch linkage.
N-S	Ditch section leading to brick culvert providing access into Webbs Fen.	<p>The culvert at point S is not in good condition and there is at least 300mm of silt within the ditch. The ditch can flow from point S to point N or point T, although the original design was likely to be both ways as this ditch acts as a cut-off between higher ground and the lower fen.</p> <p>At, or around, point S a pipe from the south outfalls which takes water from a former ditch dividing two parcels of land at Fen Farm. This pipe was not located.</p>
S – T	Ditch section from culvert at point S towards point T and then on to point X.	This ditch section appears in better drainage condition than other ditches which transport water towards the river, in this case outfalling at point X.

T	A brick arch culvert connecting drainage ditches from higher ground into the fen system.	This is an important culvert but appears to be in poor condition, although water was flowing into the ditch system which outfalls at point X.
U	Drain outfall from agricultural land to the south within the ownership of Mr Aves.	The drain was close to the ditch bed and, therefore, at risk from submergence if levels build up within the ditch. It is understood that the ditch section U-T is maintained by Mr Aves, but there has been some correspondence about this. It is, however, important that this drain outfall is kept clear, but some monitoring of flows may be required to confirm water quality and any silt loading.
V	Ditch section to recently installed culvert at J.	This ditch section was running relatively well in the lower reaches, although a fallen tree had partially blocked the channel and a section cut out to allow flow. The culvert providing outfall had an upstream invert level of 20.64m. Upstream sections were less well defined.

W	Outfall into river.	Culverted outfall into river not investigated.

X	Outfall into river.	Outfall directly into river. Evidence of silting and restriction of flow into the river was apparent. Water was tending to find its own pathways.
Y	Outfall into river.	Main outfall into river from significant watercourse taking water from large catchment to the south and west. Significant evidence of silting at the junction of river and watercourse. The source of the siltation and reason for this needs further investigation.
Z	Watercourse.
