LITTLE OUSE HEADWATERS: PILOT RESTORATION PROJECT (AS BUILT REPORT)

October 2013

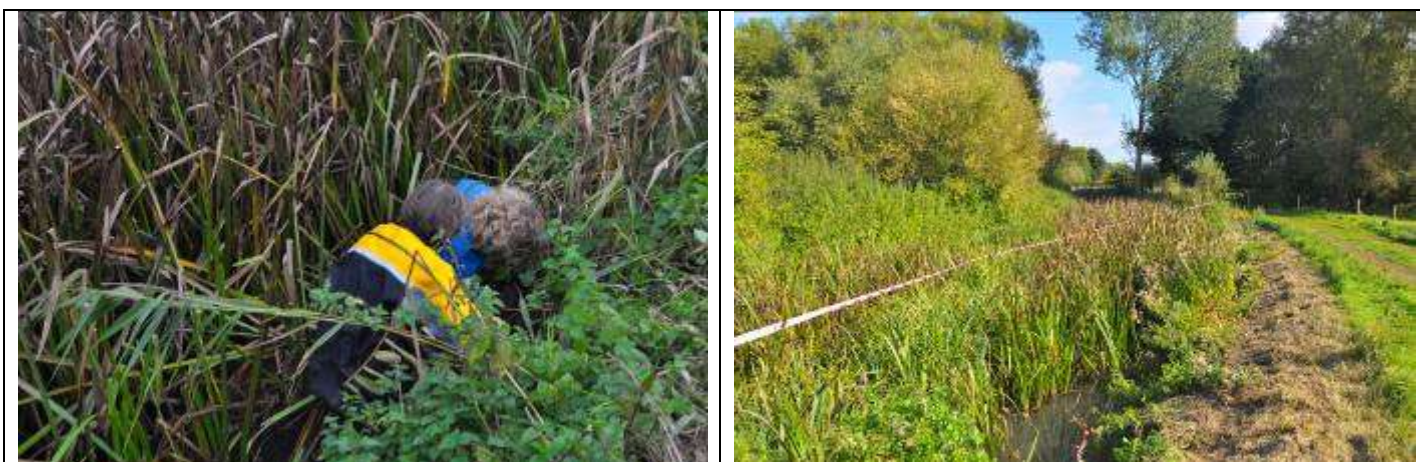
Finger-tip searches took place in advance of the work for signs of water voles, and where burrows were present, banks were clearly marked to ensure they remained unaffected by the work.

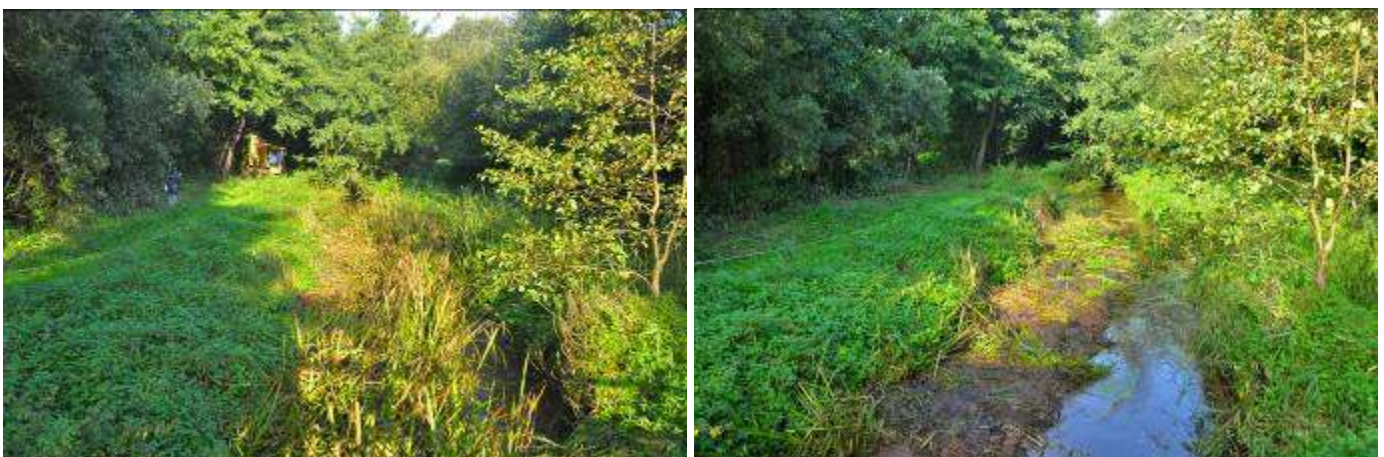
Photos 9B (Before) and 9P (Post) – Method A – simple folding of reed and silt from one side the channel to the other.

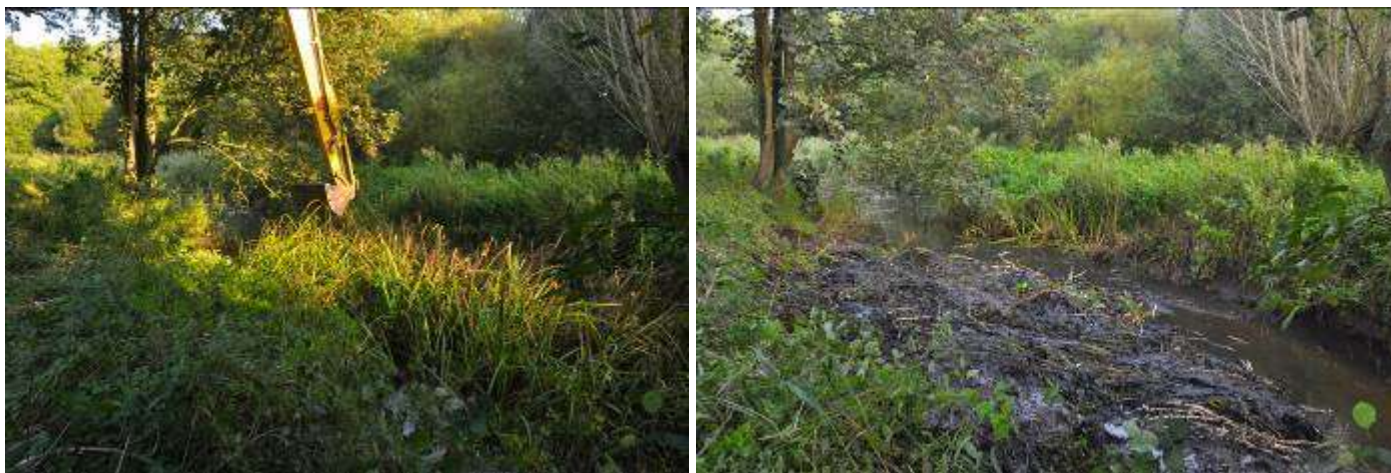
Photos 11B and 11P – Method A – simple folding of reed and silt from far side of the channel to the near side.

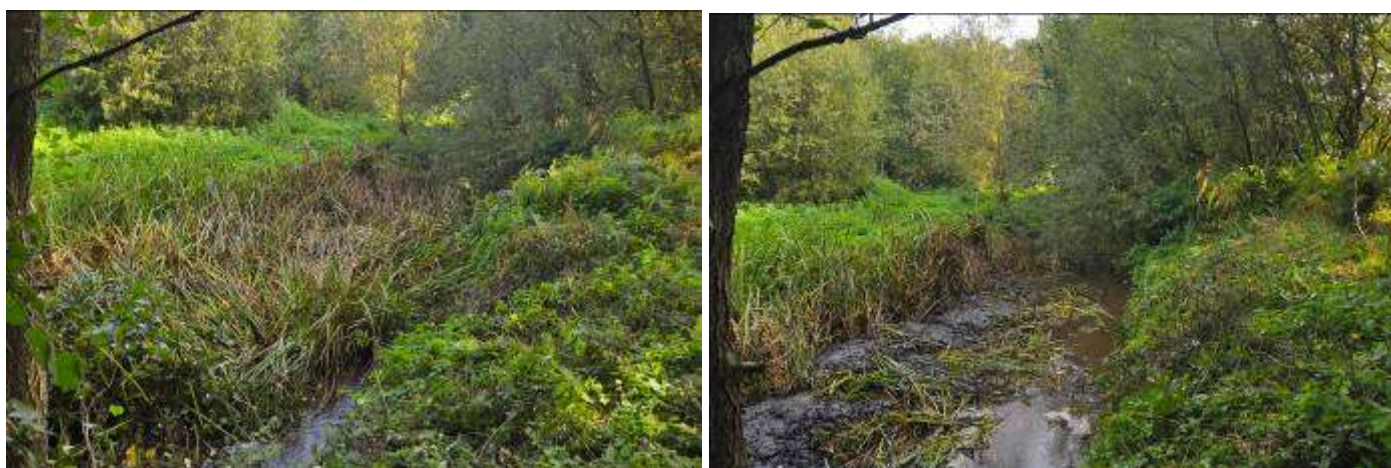
Photos 5B and 5P – Method B – simple folding of reed and silt from near side of the channel to the far side.

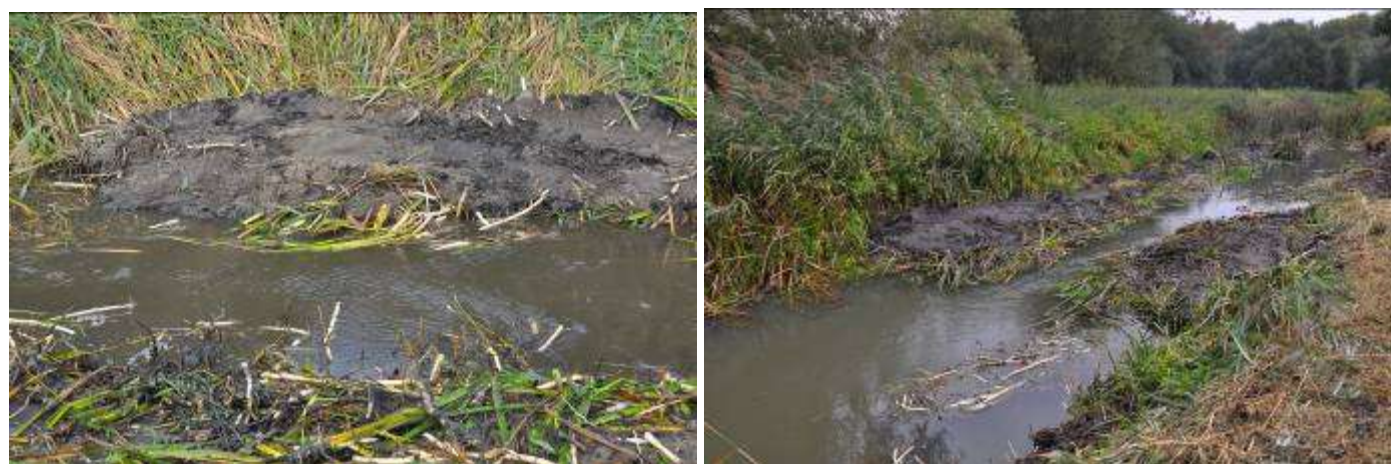
Photos 13PP and 29P. Method C – major narrowing of low-flow channel formed by shoulders on both sides of the channel upstream of pools.

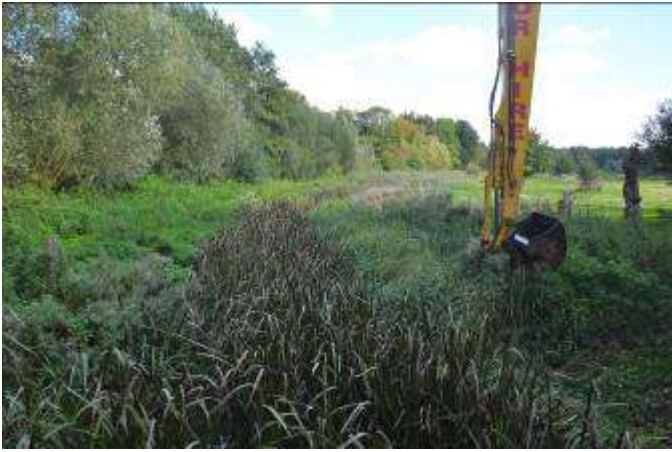
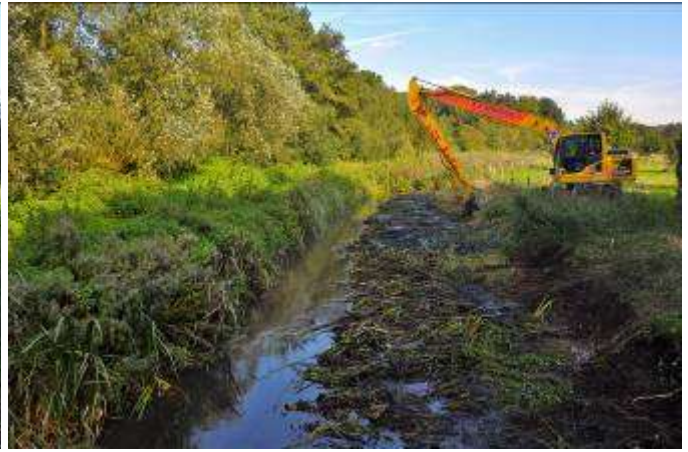
Photos 25B and 25P. Method D – major narrowing of low-flow channel by pushing into the channel a firm sedge fringe and folding in the reed and silt from the far side of the channel into void created behind the sedge fringe and the rest of the bank

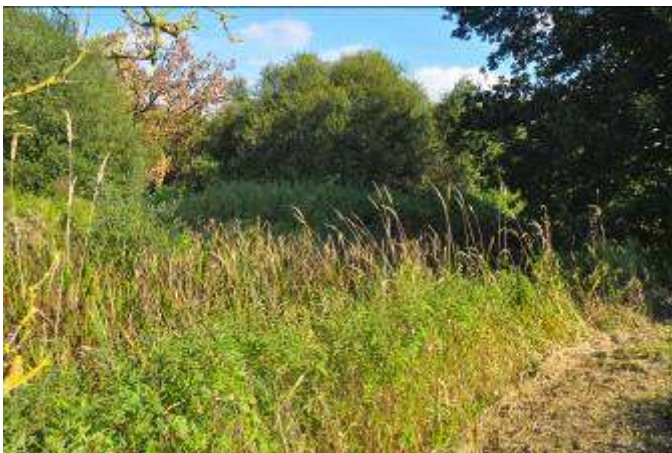
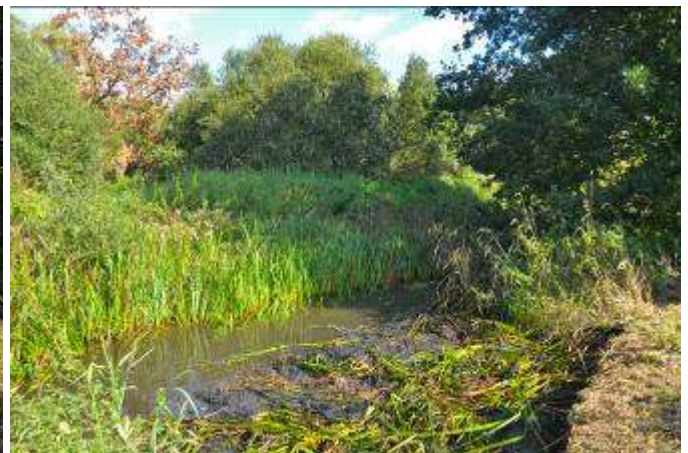
Photos 27B and 27P. Method E1 – major narrowing of low-flow channel formed by shoulder on left bank created using bank re-profile material and reed and silt from a third of the remaining channel (low-flow) width

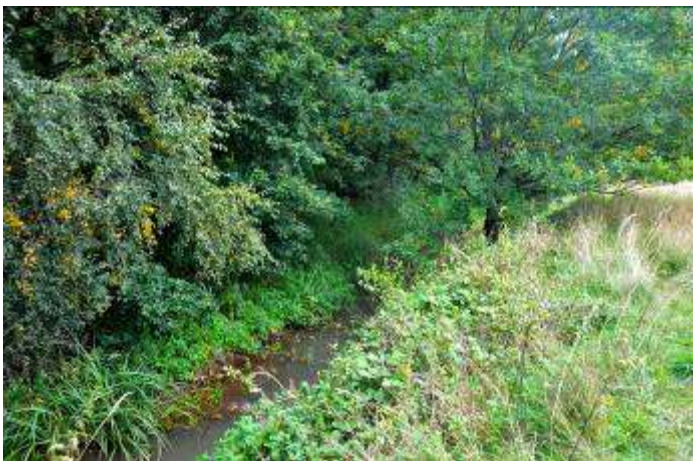
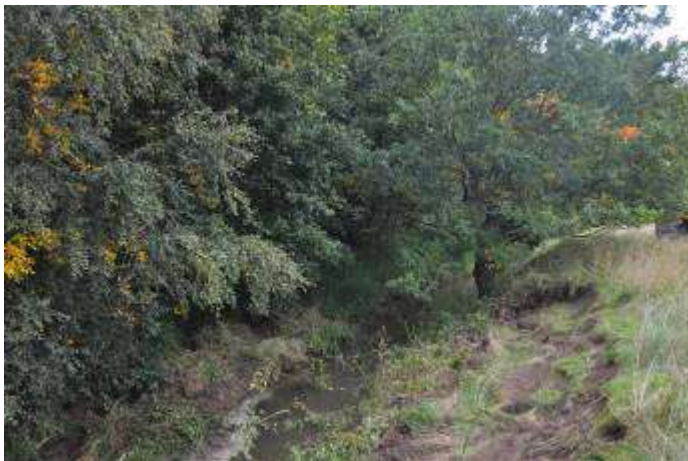
Images 3B and 3P – Method E3 - showing example of accentuating channel narrowing using top of bank spoil (TYPE E3 - only done in upper 200m).

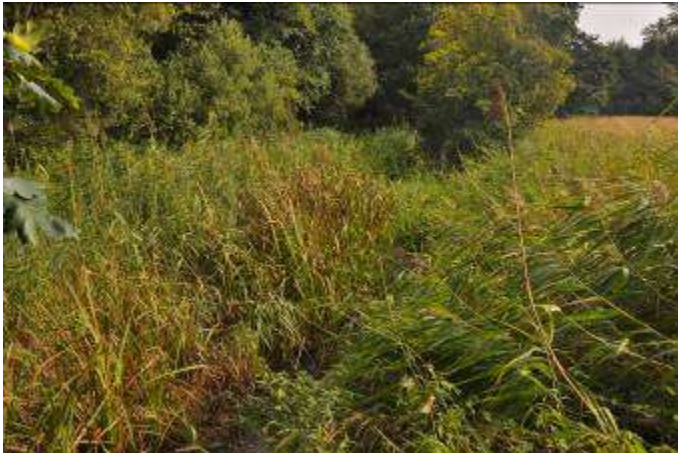
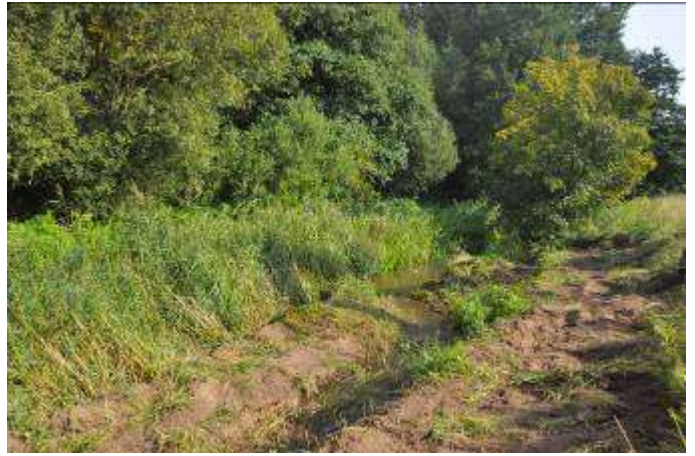
Photos 4B and 5P. Combination of Method E1, E2 & E3 – major narrowing of low-flow channel formed by shoulder on both sides of the channel created using bank re-profile material and reed and silt from a third of the remaining channel (low-flow) width

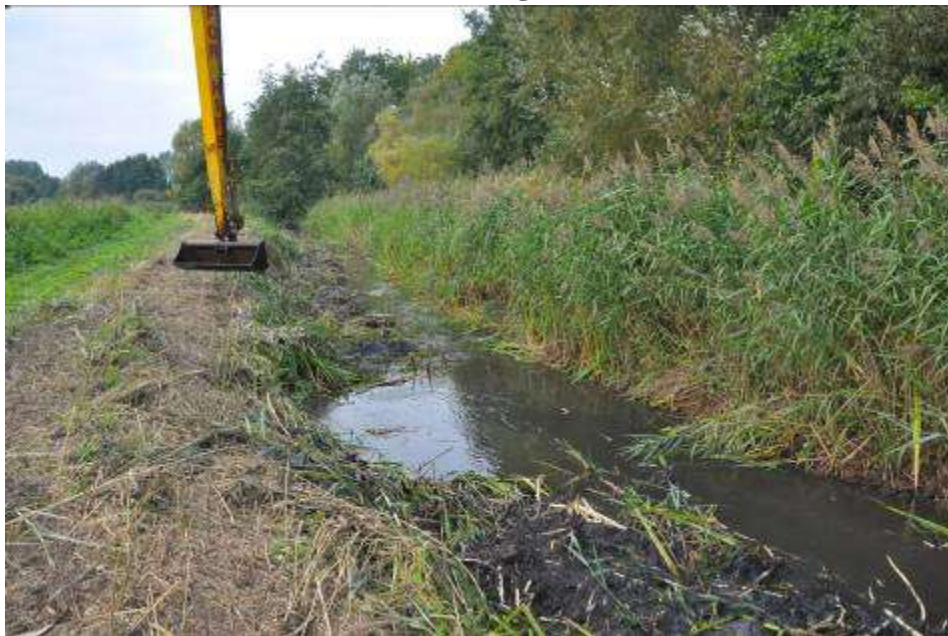
Image 16P – Method F1 – pool without vertical water vole edge

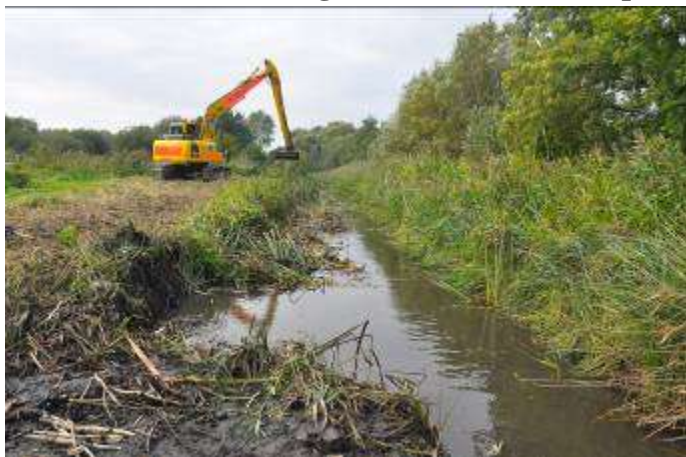
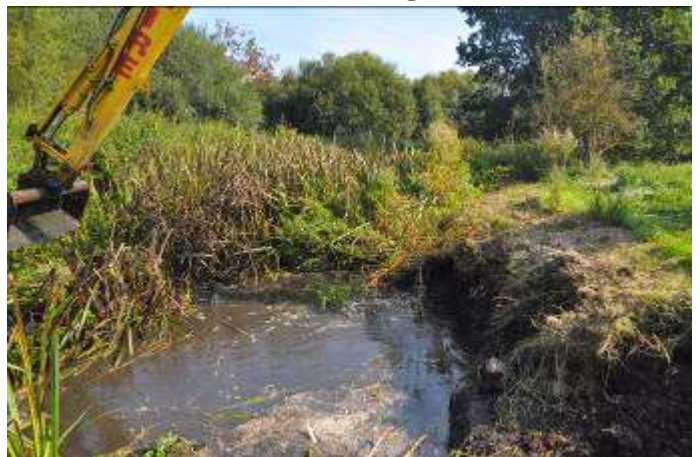
Image 14P & 28P – Method F1 – pool with vertical water vole edge
