#### **Groundwater Monitoring Points In the Upper Little Ouse Valley**

The following is a summary of known groundwater monitoring points in the headwaters area as of July 2013. It includes those installed by EA, SWT and LOHP. Grid references and photos were taken of all points and they are mapped as accurately as possible on the following maps. EA references numbers ("WISKI") are provided where known. These are often shown on site. There is no stratigraphy available or information on which layer some of the EA piezometers are recording – EA should have this information. Nor is it known which of the following are being recorded or by whom.

This was compiled by Mike Harding from information supplied by EA and Peter Frizzell (who installed new shallow dipwells and gauge boards for LOHP in June 2013).

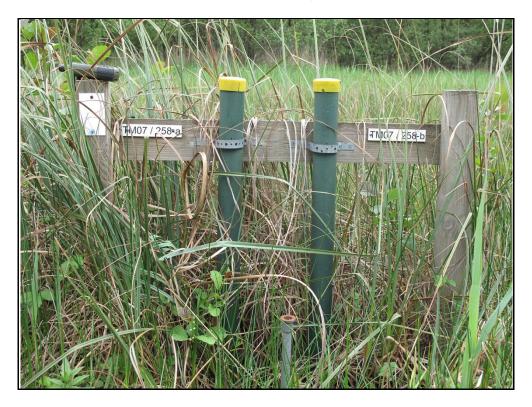
Photo 1: Blo Norton Fen TM07/ 258a and 258b

Photo	Мар	Reference	NGR	Comments
No.	No.	No.		
1	1	TM07/258a	TM 02008 78955 (EA)	Middle of fen. Recording layer not
		TM07/258b	TM 02005 78963 (MH)	known. Includes Datum post
2 & 3	1	TM07/166	TM 02068 78935 (EA)	In private field next to fen. Marked
		TM07/167	TM 02081 78923 (MH)	by red & white post. Two tubes
				within concrete apron under steel
				flaps, no caps. No indication which is
				which or the layers recorded.

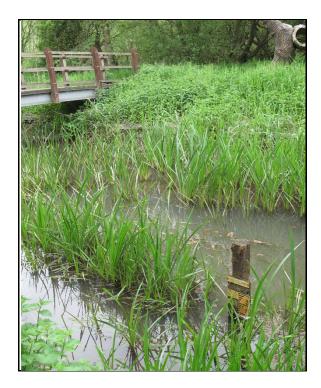
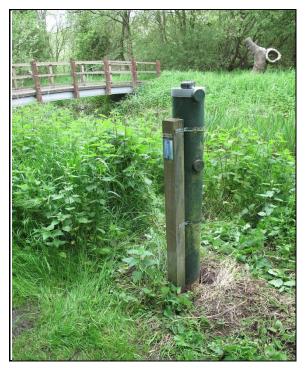
Photos 4 and 5 :TM07/248 Little Ouse Stageboard with automatic recorder, between Old Fen and Blo' Norton Fen.

Photo	Мар	Reference	NGR	Comments
No.	No.	No.		
4 & 5	1	TM07/248	TM 01959 78850 (EA)	River gaugeboard with automatic
			TM 01940 78856 (MH)	recorder adjacent.
6	1	TM07/247	TM 01990 78810 (EA)	Gaugeboard in ditch between Old
			TM 01997 78824 (MH)	fen and private land. Ditch dry.
7	1	TM07/246	TM 01958 78819 (EA)	By the path in Old Fen.
			TM 01976 78778 (MH)	
8	1	TM07/257a	TM 01924 78718 (EA)	Middle of Old Fen
		TM07/257b	TM 01923 78728 (MH)	
9	1	TOF 1	TM 01913 78707 (MH)	Grey pipe dipwells with datum post.
				Installed by SWT. New reference
				number. Possibly the missing EA
				dipwells 242 and 243?
10 &	1	TM07/245	TM 01818 78630 (EA)	Cluster of 3 pipes. Water was heard
11		TM07/244	TM 01821 78634 (MH)	bubbling up pipe 244 on 30/05/13,
		TM07/252		with water overflowing through hole
				15cm above ground level. Suggests
				groundwater rising under artesian
				pressure, well above ground surface.

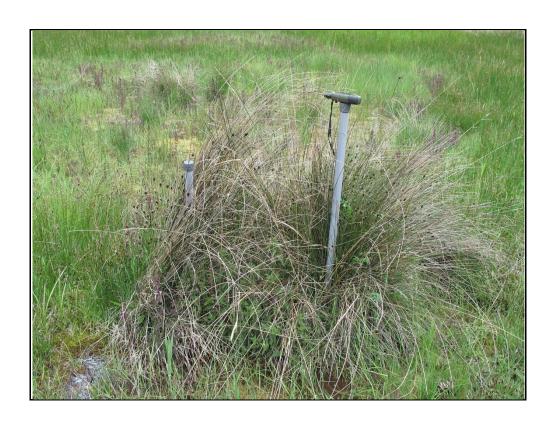
Photo 9: TOF 1 SWT Dipwells. No EA reference. Centre of Old Fen.

**NOTE:** EA dipwells TM07/242 and TM07/243 could not be re-found. The NGR given of TM 01889 78790 placed the dipwells in the middle of the alder carr. It is possible that the GPS cords supplied are incorrect and that these two dipwells are the same as the grey SWT dipwells with photo no. 9.

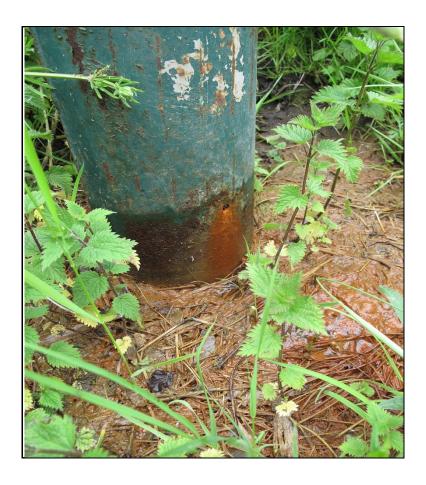
Photo 11: Near to ground level of TM07/244. Water rising in tube and leaking out.

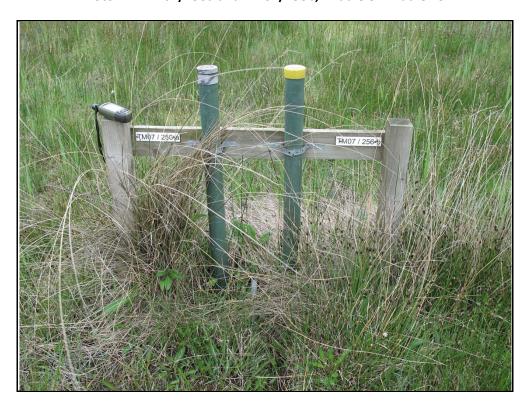
Photo 12: TM07/256a and TM07/256b, middle of Middle Fen

Note that TM07/240 and TM07/241 were not found. EA's GPS coordinates (TM 01466 78722) put them bear to TM07/256a/b, in the fen vegetation of Middle Fen, but no trace could be found. There used to be grey dipwell tubes much like Photo 9, but these were absent – perhaps the lost dipwells?

Photo	Мар	Reference	NGR	Comments
No.	No.	No.		
12	1	TM07/256a	TM 01472 78725 (EA)	Paired dipwells in the middle of
		TM07/256b	TM 01469 78733 (MH)	Middle Fen
13	1	TM07/249	TM 01622 78839 (EA)	Near to the path.
			TM01616 78844 (MH)	
14	1	TM07/250	TM 01614 78834 (EA)	Stage board and recorder in ditch
			TM 01606 78842 (MH)	between Middle Fen and private
				land

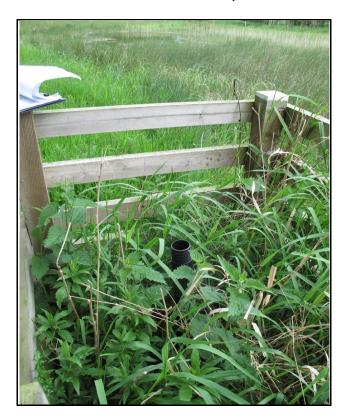
Photo 15: Parkers Piece, P1.

Photo	Мар	Reference	NGR	Comments
No.	No.	No.		
15	2	P1	TM 01314 78955 (MH)	Parker's Piece. Black pipe dipwell in
				exclosure near trees on raised
				margin.
16	2	B1	TM 01535 78947 (MH)	Bleyswyck's Bank. Black pipe dipwell
				in exclosure on margin.
17	2	P2	TM 01316 78791 (PF)	Scrape in Parkers Piece. Stageboard.
18	2	P3	TM 01323 79037 (PF)	River Gaugeboard.

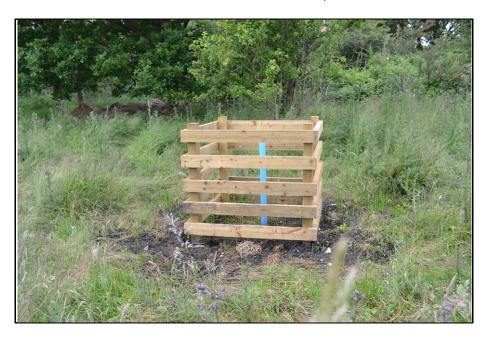
Photo 19: Broomscot Common, B1.

Photo	Мар	Reference	NGR	Comments
No.	No.	No.		
19	3	B1	TM 00427 80785 (PF)	Dipwell in fen north of the drain
20	3	B2	TM 00428 80775 (PF)	Stageboard in stream

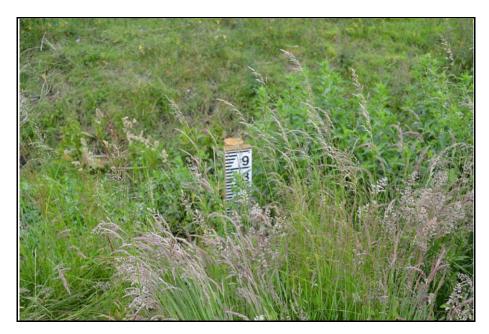
Webbs Fen

Photo	Мар	Reference	NGR	Comments
No.	No.	No.		
21	1	W1		Dipwell adjacent to the new scrape,
			TM 01718 78883 (PF)	east side.
22	1	W2	TM 01696 78812 (PF)	Dipwell in the middle of the field.
23	1	W3	TM 01670 78706 (PF)	Dipwell near to the gate.
24	1	W4	TM 01723 78979 (PF)	Stageboard in the river

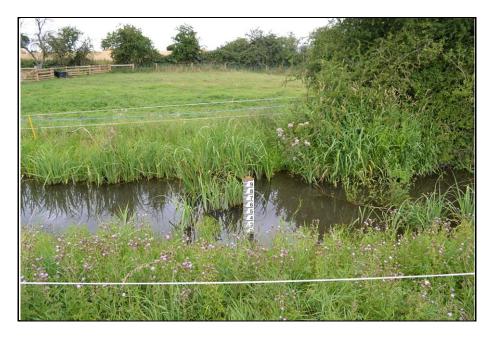
Photo 25: Scarfe Meadows, S1

Photo	Мар	Reference	NGR	Comments
No.	No.	No.		
25	4	S1		Gaugeboard in the main east-west
			TL 99732 80835 (PF)	drain
26	4	S2		Gaugeboard in the north-south
			TL 99757 80754 (PF)	middle drain
27	4	S3	TL 99693 80703 (PF)	Gaugeboard in the river

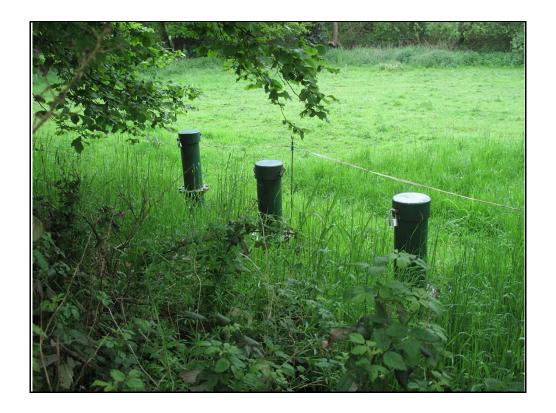
Photo	Мар	Reference	NGR	Comments
No.	No.	No.		
28	2	TM07/259A	TM 01492 79174 (EA)	Row of three casings on private
		TM07/259B		meadow west of Blo' Norton Fen,
		TM07/259C		next to Fen Road.

Photo 28: TM07/259A, TM07/259B, TM07/259C. Private meadow next to Fen Road.
