Little Ouse Headwaters Project: River Macrophyte Survey 2013

by OHES on behalf of

Little Ouse Headwaters Project
17th December 2013

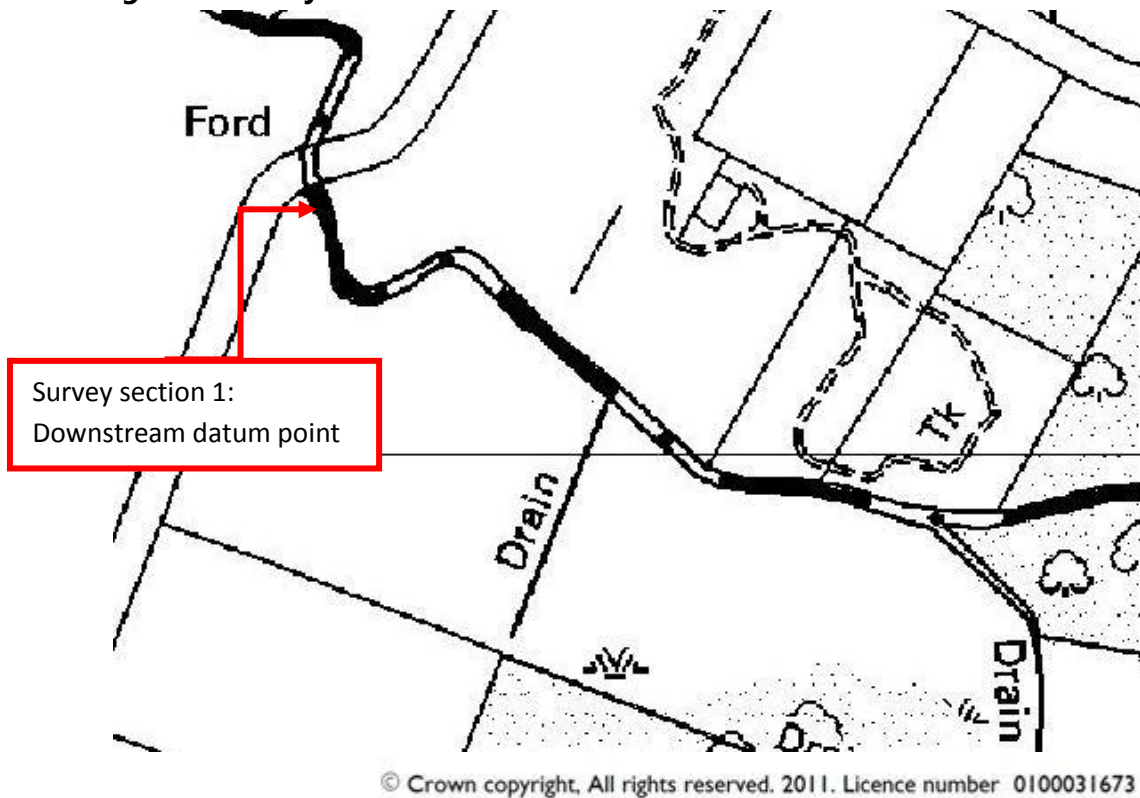
Figure 1. Survey section location: Parker's Piece

As shown in Figures 1 and 2, relocatable survey sections have been established beside Parker's Piece close to the road bridge and between Blo'Norton Fen and Webb's Fen. The exact locations of both sections are described in sections 2.3 and 2.4.

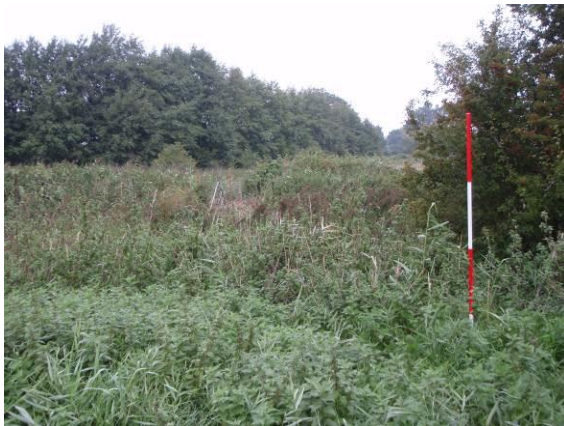
Photo 3

The upstream end should be relocated by measuring along the top of the bank from the downstream datum point. As established, the datum point is on the river bend (Photo 4) approximately opposite to the point where the fenceline on the opposite bank meets the river (Photo 3). As indicated in Photo 3, the section was temporarily marked by a pole located c.3 metres south of the hawthorn bush and c.9 metres northwest of the first oak along the bank in an upstream direction.

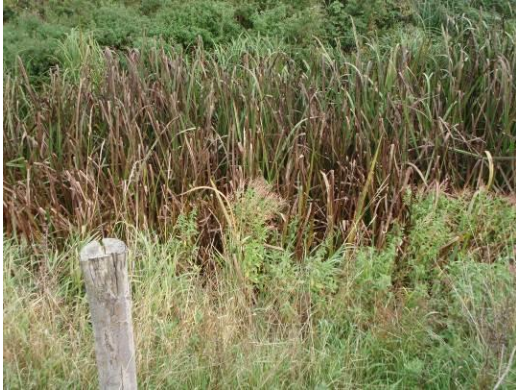
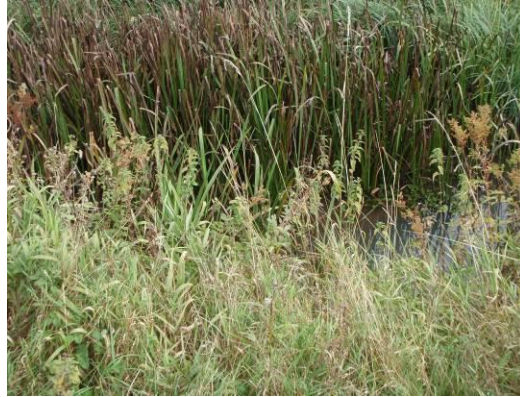
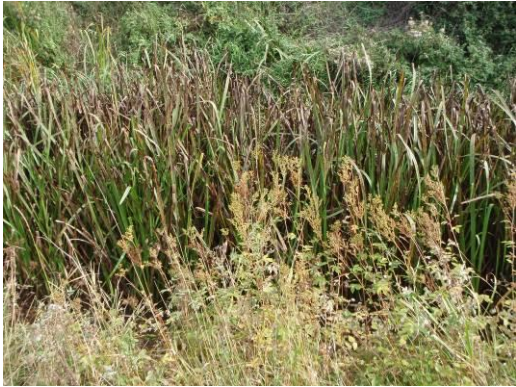
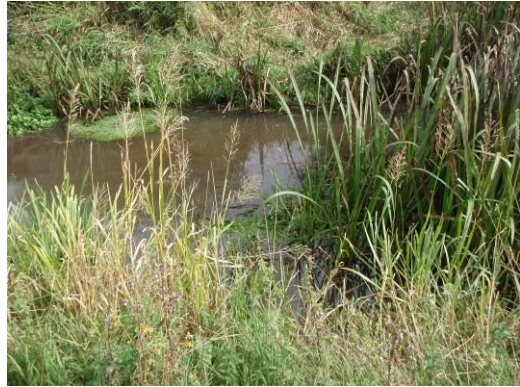
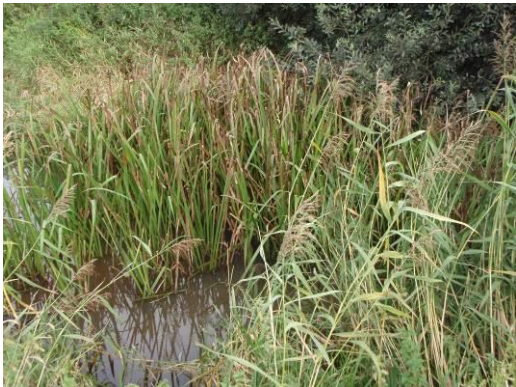
Downstream of the river bend in the centre of the section, reedswamp is replaced by patchy stands of the emergent Branched Bur-reed *Sparganium erectum*. This is the mono-dominant S14a *Sparganium erectum* swamp community in the NVC. Although forming a more-or-less continuous ribbon along this part of the section, this swamp is prevented from choking the entire channel by a sinuous flowpath of moving water. The rhizome structure of the bur-reed is known to be quite fragile in flowing water (e.g. CEH 2004²), and the growth of the stand may be controlled by pruning of extension growth during periods of significant flows.

Within the Bur-reed stands, and particularly extending from shallow silts into the unshaded river flowpath, small patches of submerged Fool's Water-cress *Apium nodiflorum* form the main features of a thin scatter of marginal species, including also occasional Lesser Water-parsnip *Berula erecta* and Water Forget-me-not *Myosotis scorpioides*.

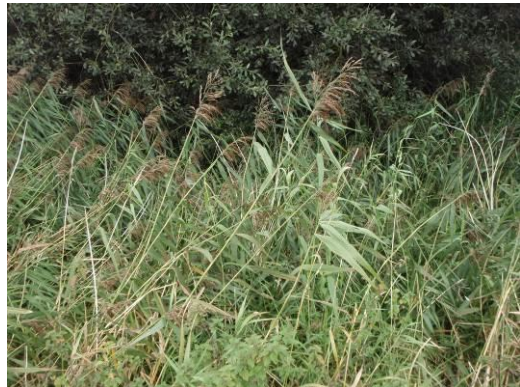
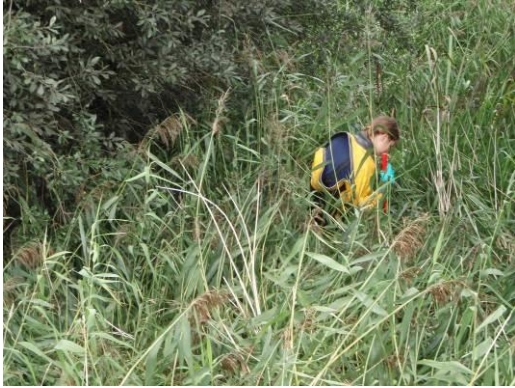
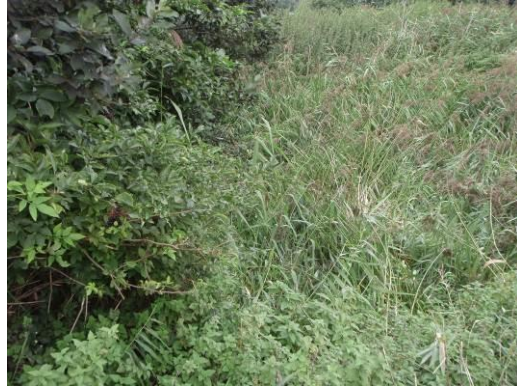
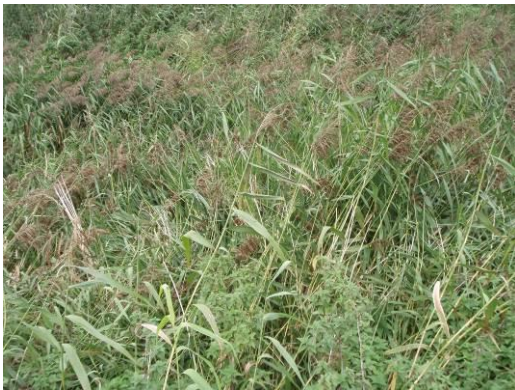
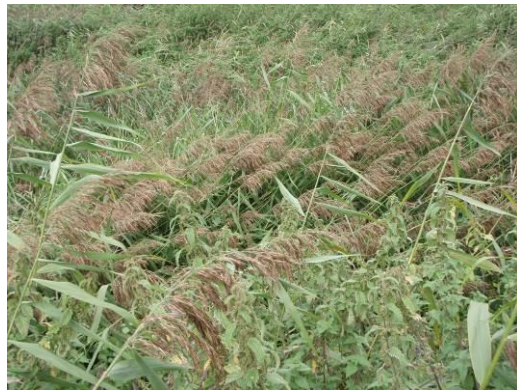
As shown in Photos 10-14 and 5-9, the section supports two main vegetation stands. The upstream part is dominated by a tall stand of Common Reed *Phragmites australis* that can be referred to the eponymous sub-community of S4 *Phragmites australis* reed-swamp (S24a) in the NVC. In this part of the section, unshaded water was absent and no other species was recorded as emergent or aquatic by the survey, though Common Duckweed *Lemna minor* fronds are likely to be washed through the vegetation during periods of appreciable flow. There is little shading from bankside shrubs, but by this stage of the growing season the tall eutrophic fen vegetation on both banks adds to the shading effect of the reed swamp.

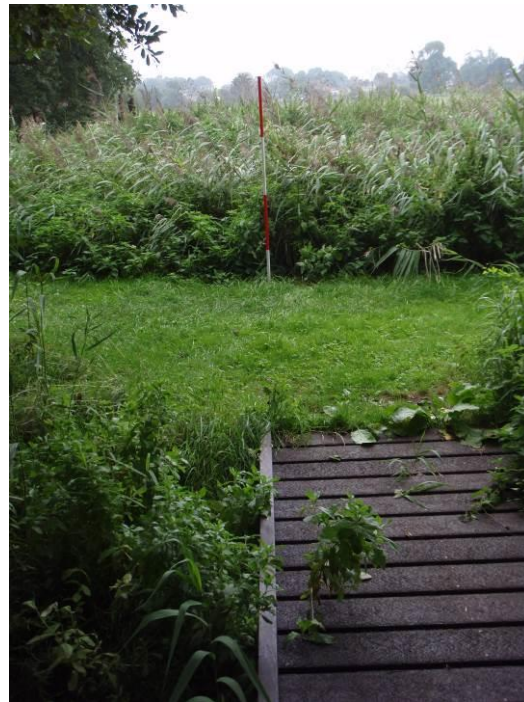
Photo 15

Written description: For relocation, the upstream end of the survey section is established on the top of the river bank in a direct line extending from the eastern edge of the boardwalk entering Blo'Norton Fen (Photo 5).

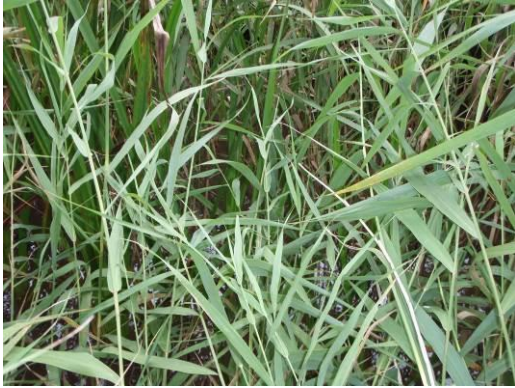
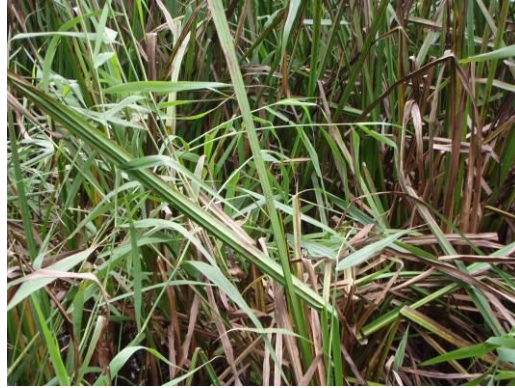
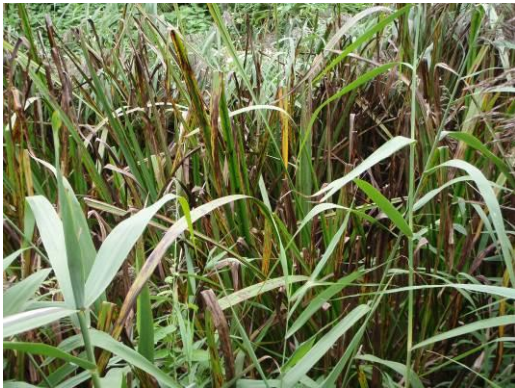
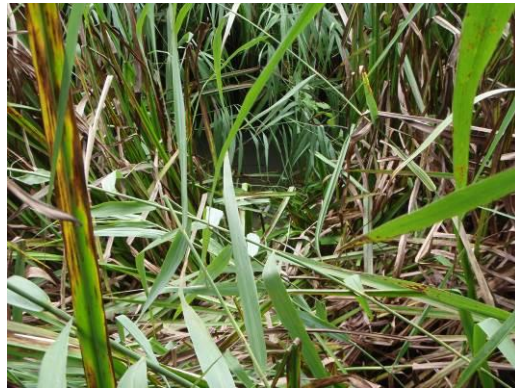
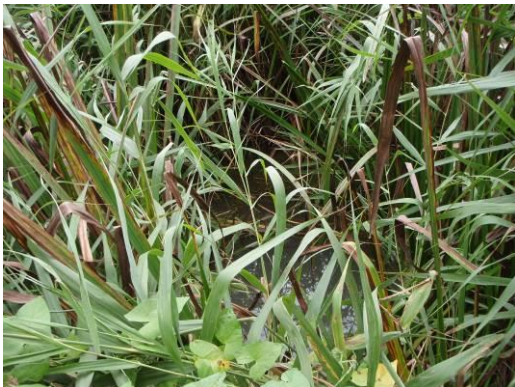
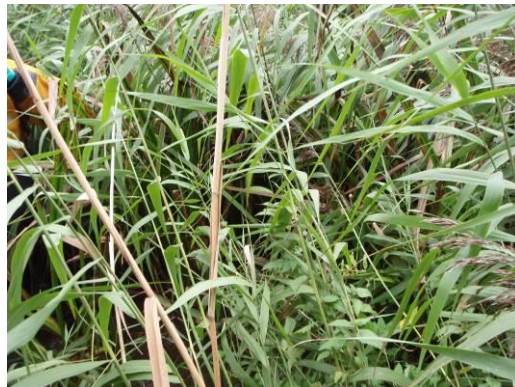
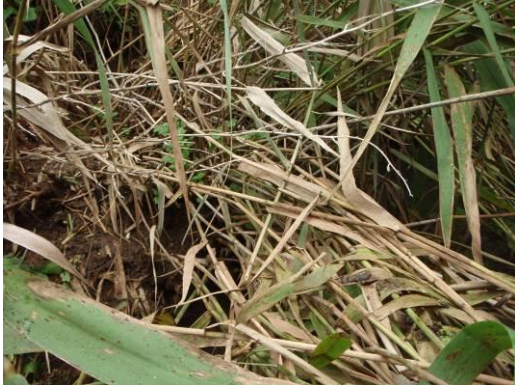
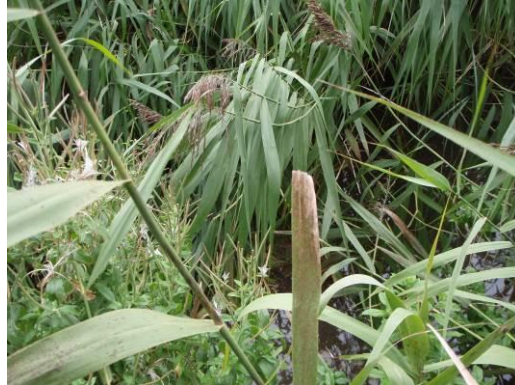
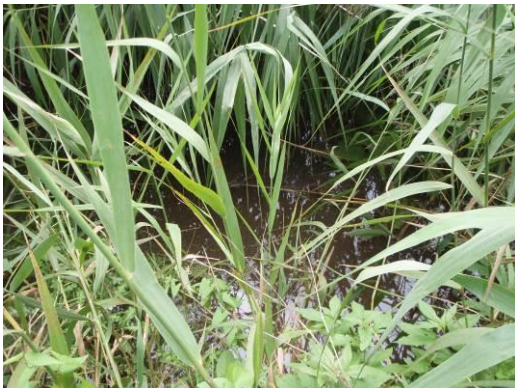
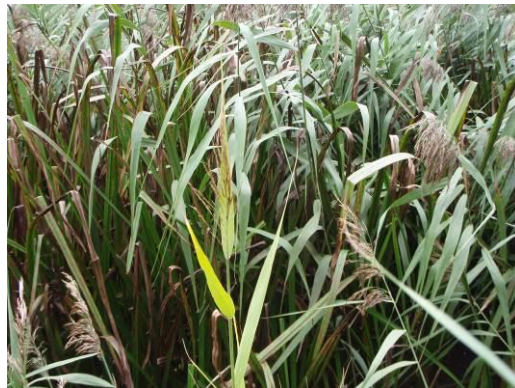
As shown in Photos 16-25, the section supports two main vegetation stands, but in several sub-sections, the two dominants (Branched Bur-reed and Common Reed) intergrade. Where one of these emergent species is dominant, stands may be referred to either the S4a *Phragmites* reedswamp or the S14a *Sparganium* swamp, as noted in section 2.3.2. No other species is more than occasional, and the flora is restricted to the floating Lemnid Common Duckweed and a scatter of fen or marginal species.
