Little Ouse Headwater  
Project:  
Pre-restoration survey  
for aquatic invertebrates  
2013

Survey carried out by Toby Abrehart FLS

This report details the results of the aquatic invertebrate survey carried out in September 2013 prior to the commencement of works by the EA.

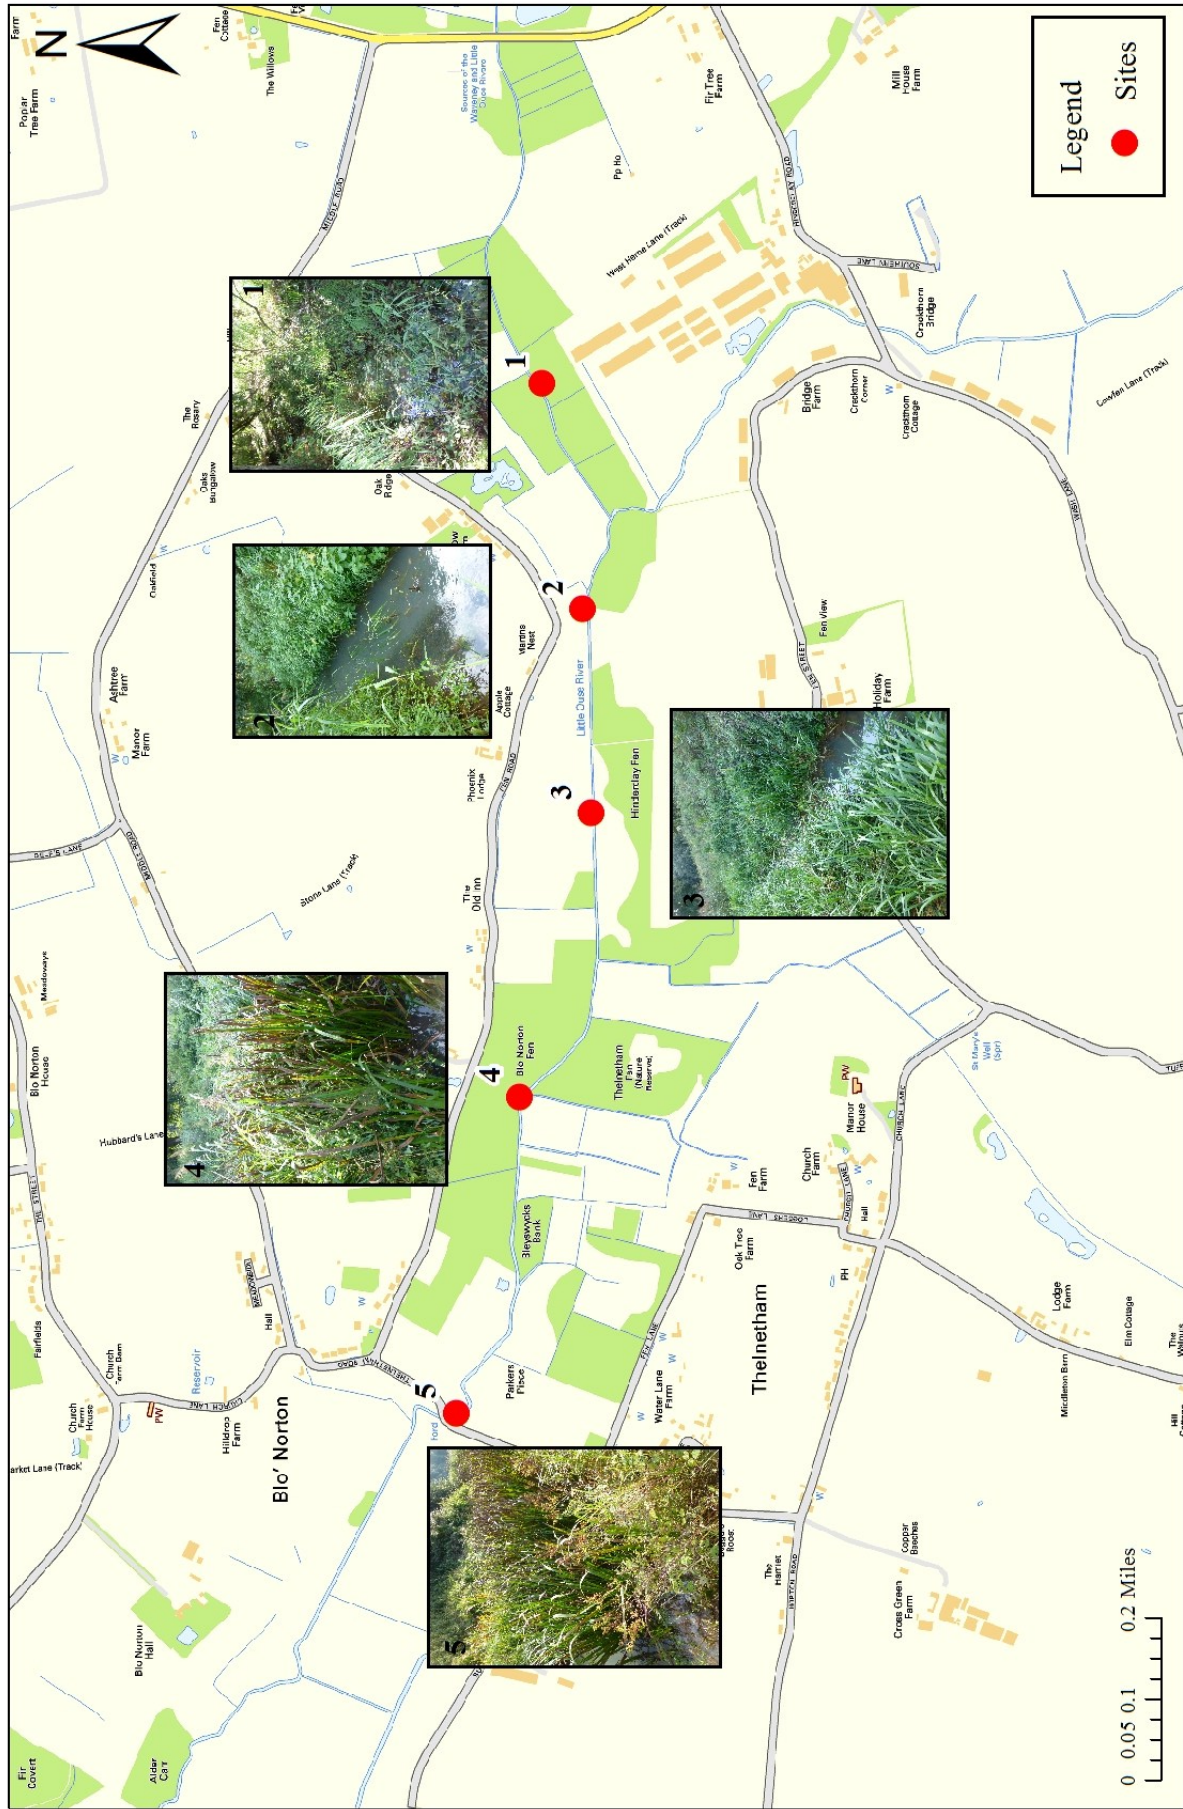
Figure 1. Location and photos of sampling sites, 27th September 2013

The sampling sites selected for this survey were located on the river adjacent to land within the LOHP area (figure 1), namely The Lows, Hinderclay Fen, Blo' Norton Fen, Webbs Fen and Parkers Piece.

There was considerable change in the habitat and channel characteristics downstream from site 1 to site 5 (appendix A). At site 1, there was no apparent flow of water and the channel was choked with detritus, whereas downstream the channel increased in size and there was a flow of water up to 50cm deep.
