Fieldwork to Support Habitat Restoration Work at Scarfe Meadows, Garboldisham

Undertaken on behalf of the Little Ouse Headwaters project
by

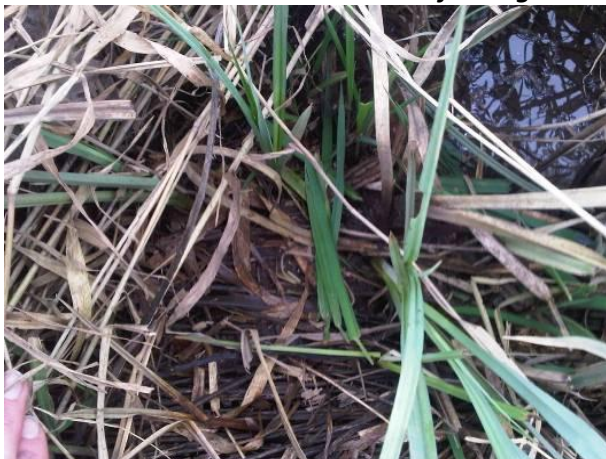
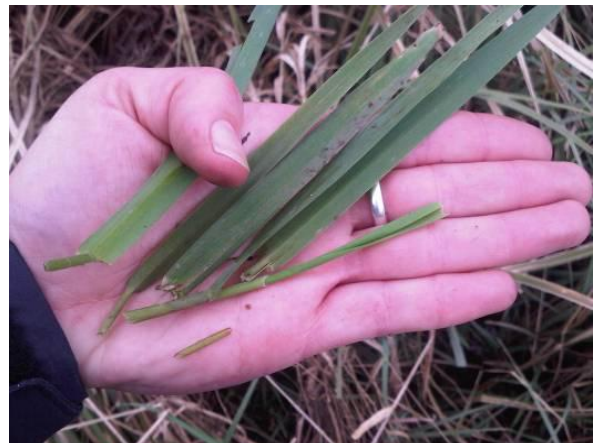
A feeding station (store of cut grass stems in the characteristic way of food stored by water voles) was identified beneath lodged reed adjacent to the northwest ditch (Photos 5 and 6, Figure 2). This is believed to be the food store of a water vole, however, further signs (to include droppings) would be required for a positive confirmation of water vole presence and to design appropriate mitigation.

Photo 5 and 6: Probable water vole feeding station

1. Signs of probable water vole activity were found adjacent to one drain within Scarfe Meadows, and subsequently confirmed by a later survey undertaken by Suffolk Wildlife Trust. Therefore, if any works are proposed to the ditches/river banks or to raise water levels, a mitigation plan should be drawn up encompassing known populations areas, using designs consented by natural England, where works are deemed possible and necessary.

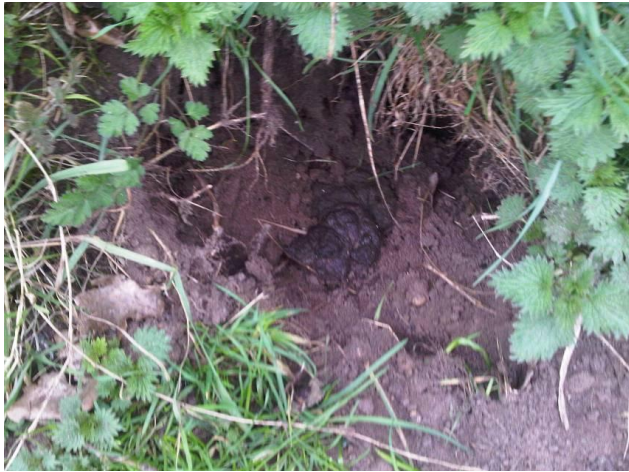
It is also noted that a badger dung pit was identified in a rabbit burrow above the culvert in the north-south ditch of Scarfe Meadows (as shown in Photo 7 and Figure 2). The latrine appeared to have been used twice within the recent past. There were no further signs of badger activity or setts within the survey area.

Photo 7: Badger dung pit

6. A badger latrine was identified within Scarfe Meadows (as shown on Figure 2). Badgers and their habitats are protected from harm, damage and disturbance by Schedule 5 of the Wildlife and Countryside Act, 1981. However, no further signs of badger activity were noted, such as setts or paths, so it is likely that this area is not frequently used by badger and that the latrine is the result of an individual passing through the site. There is local anecdotal evidence (Reg Langston pers. comm. 30/03/11) that the badger sett is believe to be on higher ground, beyond the survey area. Provided the proposed works will not lead to a significant change of land use, or prevent access for badgers no further surveys are required. Mitigation measures to protect any badgers that may pass through the site during the works must include:

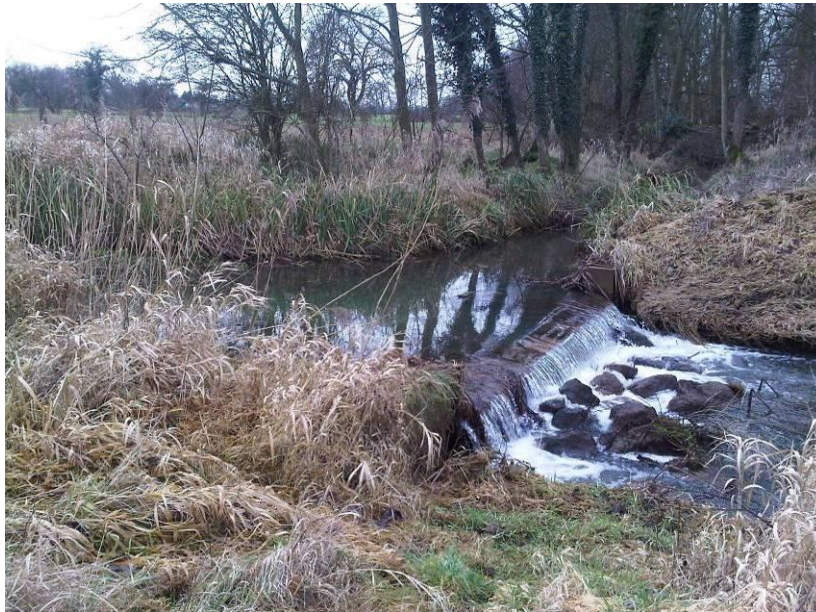
Photo 8: Weir

To the south of the Meadows is the River, including a weir (at 17.98mOD) which retains water at a higher level upstream (east, Photo 8). The weir may also be useful as a temporary benchmark.

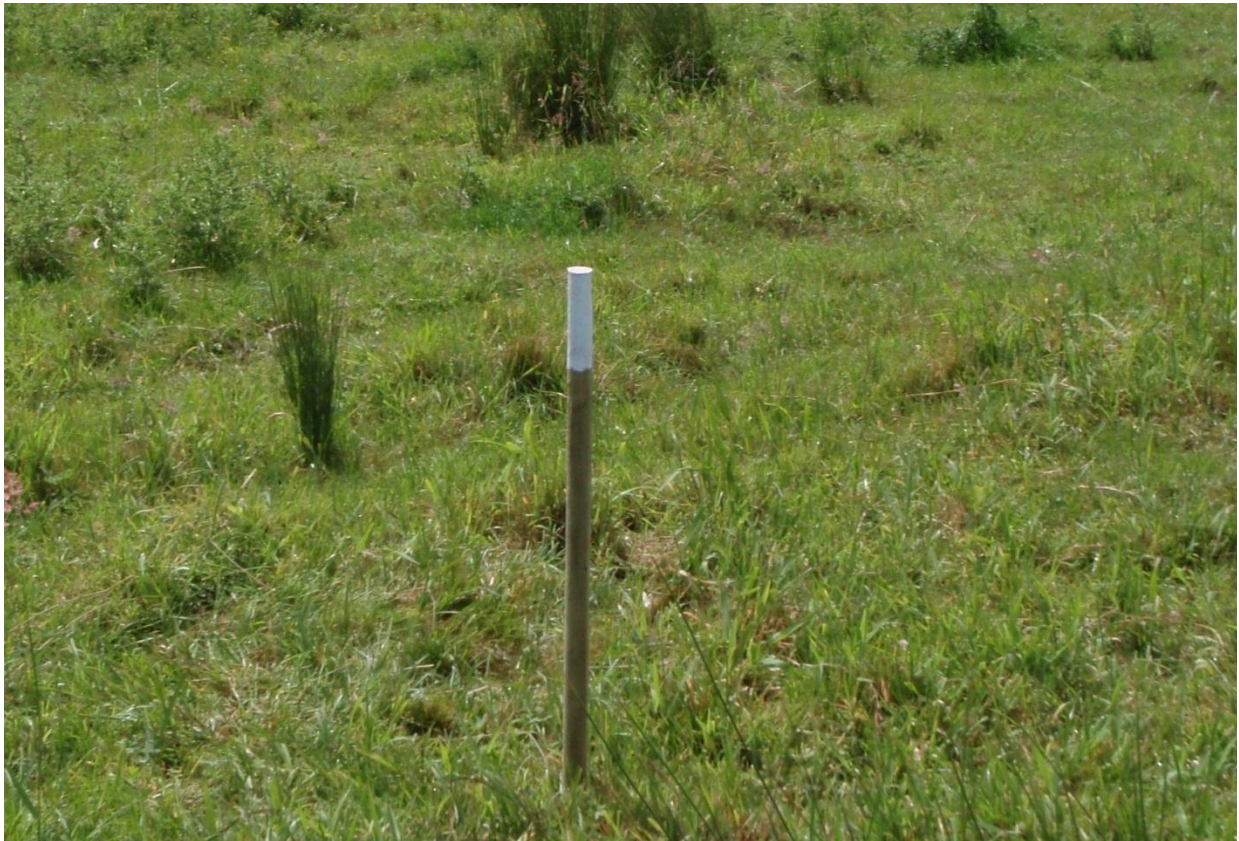
Photo 9. Grassland marker post type

Each plot is 10 m x 10 m in size, and lies between the two permanent marker posts. The precise location of the monitoring plot is re-established by stretching a 50 metre tape between the posts. From known lengths along this baseline, the plot is reconstructed at right angles to it. It should be noted that the precise locations of some monitoring plots may be affected by the installation of the permanent marker posts following the survey.

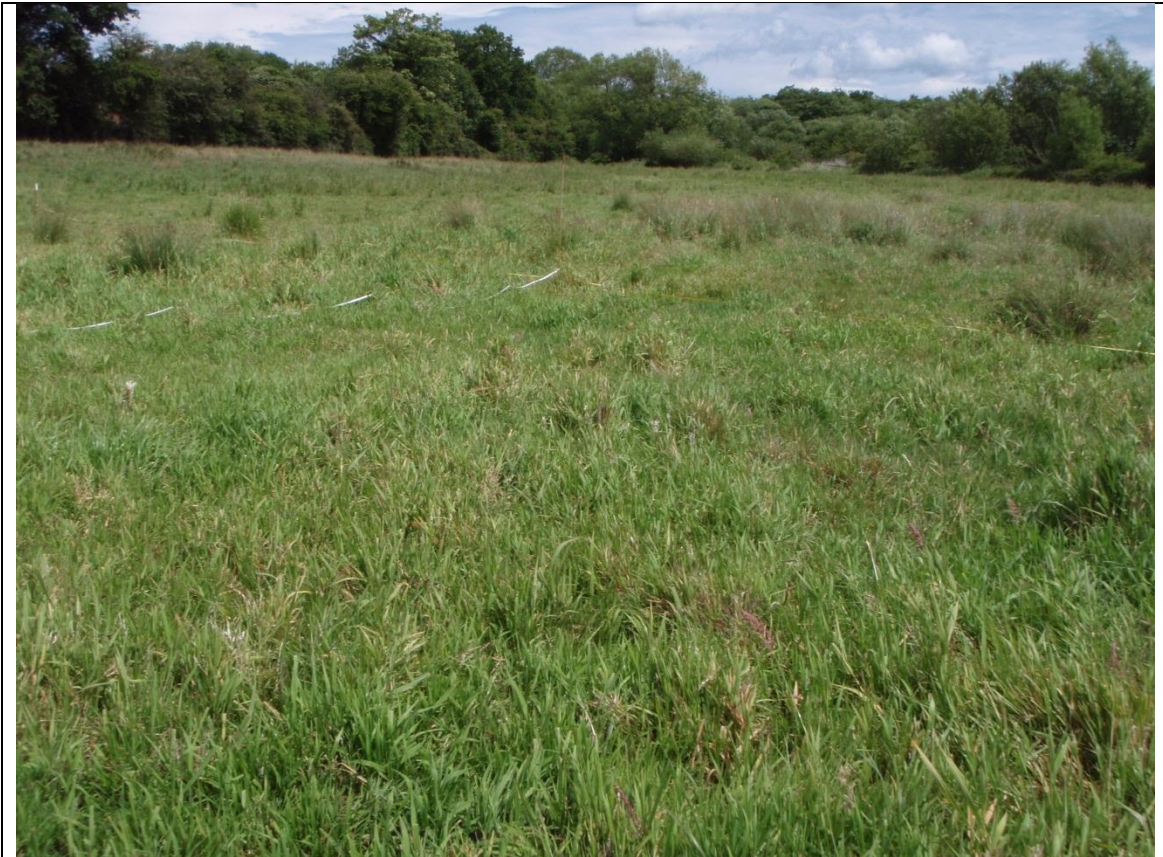
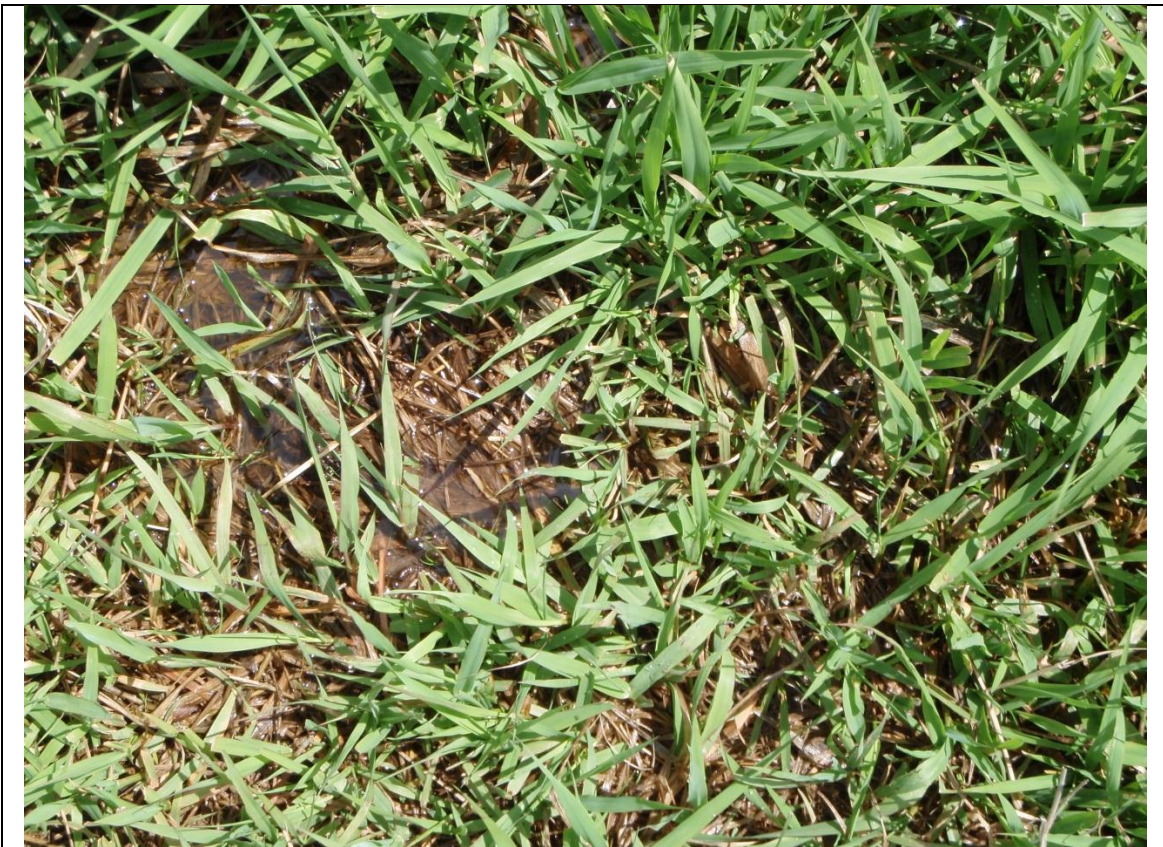
Plot code S01

<p>Relation to past and target conditions</p> <ul style="list-style-type: none"> ● This survey initiates the Vegetation Monitoring Programme and provides a baseline for assessing subsequent Parched Open Grassland development. ● Current floristics indicate that many of the Flood Pasture grasses are present, but showing the effects of a sub-optimal grazing regime for promoting smaller grasses; lack of regeneration beneath their tufted and tussocky habit also indicates a sub-optimal condition. ● The limited potential for immigration of characteristic Flood Pasture herbs and bryophytes should also be considered.

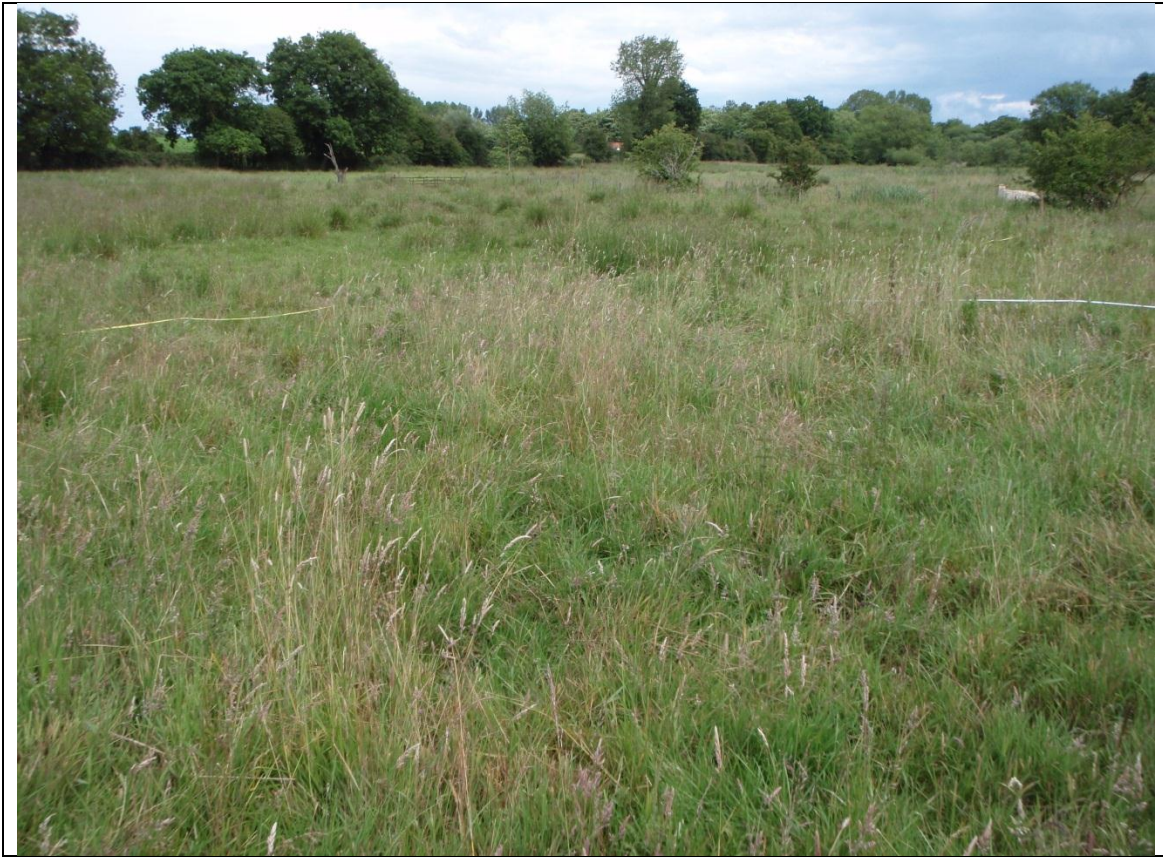
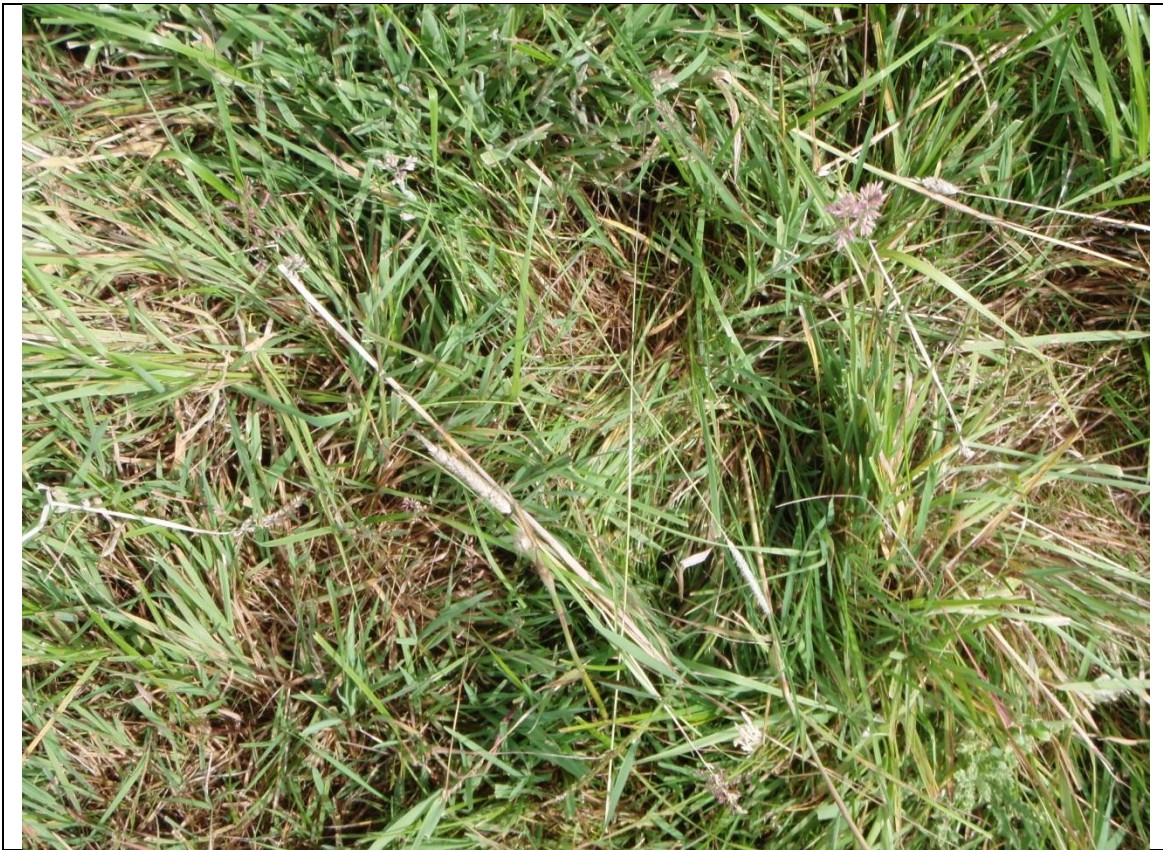
Plot code S02

The sward is currently grazed with cattle; stocking rate appears to be sufficient to head-back current foliage, but the high proportion of mature growth in this vegetation type suggests that the cattle are now grazing the earlier spring growth rather than the summer re-growth. It is also noted that areas of the eastern field and terrace margin are more strongly grazed, especially along the eastern side, indicating supplementary rabbit grazing.

The current floristics appear to indicate that many of the Flood Pasture grasses are present, but that the vegetation character is showing the effects of a sub-optimal grazing regime in recent years for promoting smaller grasses. Furthermore, the lack of regeneration beneath their tufted and tussocky habit of the strong-growing grasses also indicates a sub-optimal condition.
