## Fieldwork to Support Habitat Restoration Work at Webb's Fen, Theltham

Undertaken on behalf of the Little Ouse Headwaters project  
by

# Contents

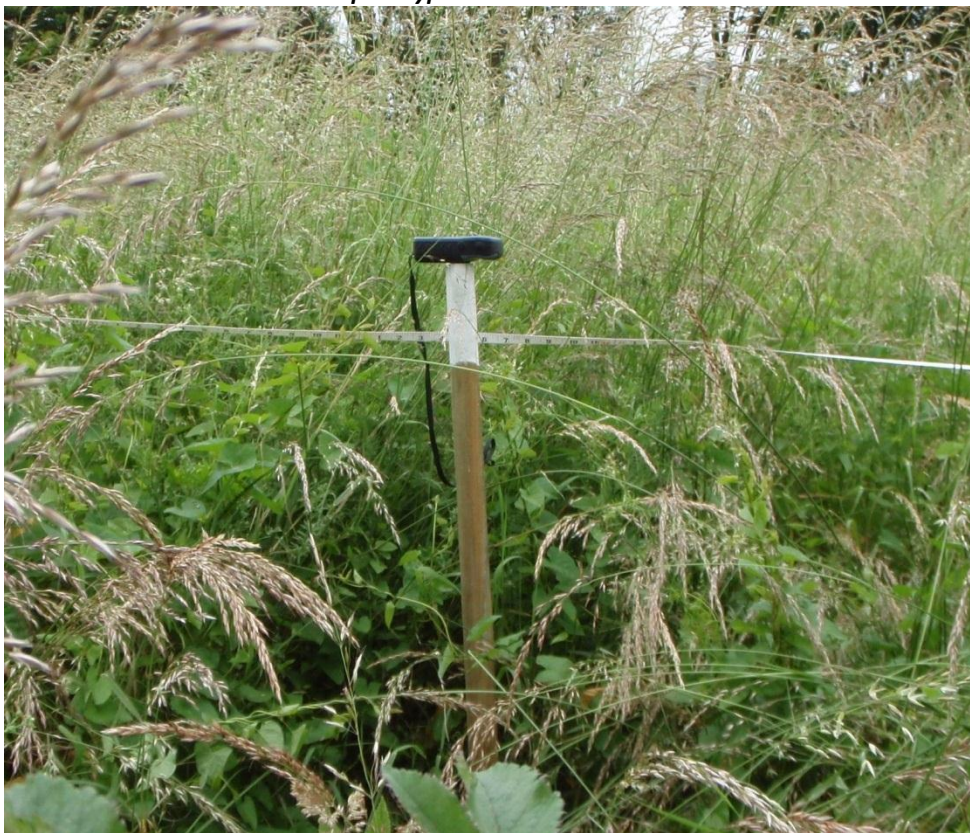
**Photo 11. Fen Meadow marker post type**

Each plot is 10 m x 10 m in size, and lies between the two permanent marker posts. The precise location of the monitoring plot is re-established by stretching a 50 metre tape between the posts. From known lengths along this baseline, the plot is reconstructed at right angles to it. It should be noted that the precise locations of some monitoring plots may be affected by the installation of the permanent marker posts following the survey.

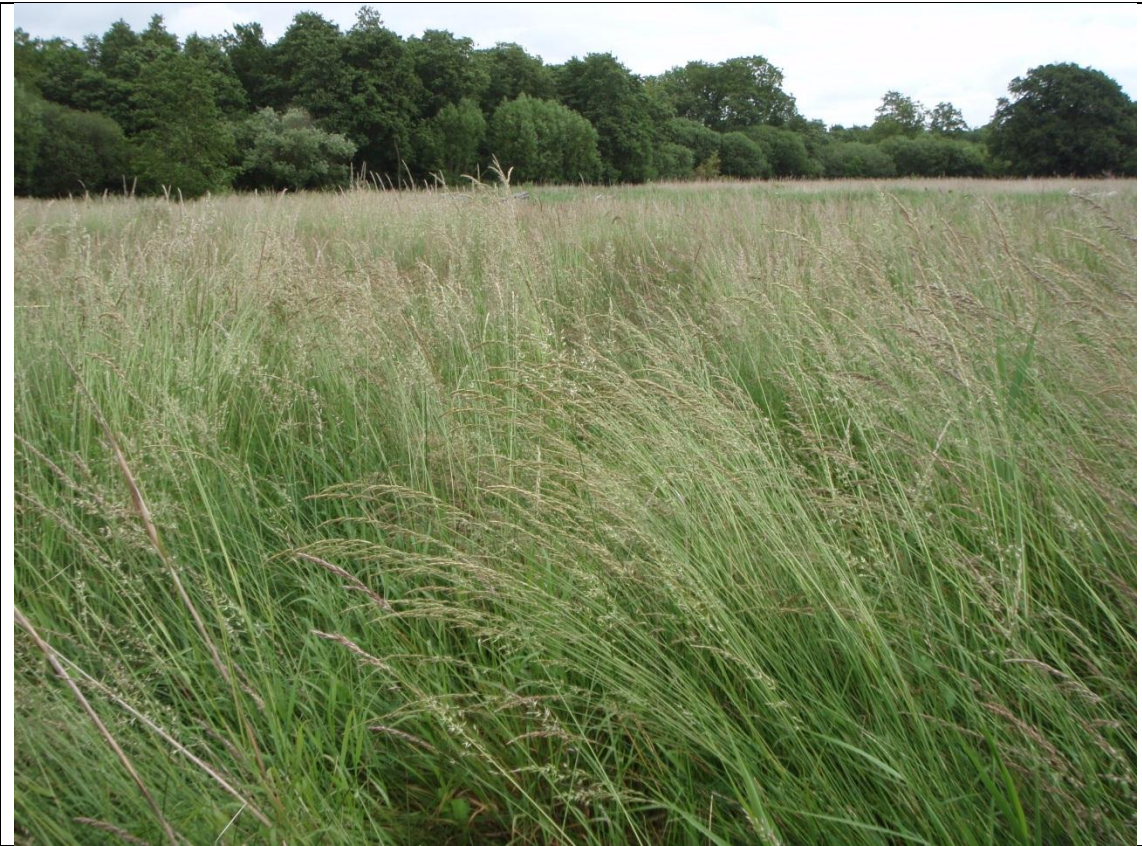
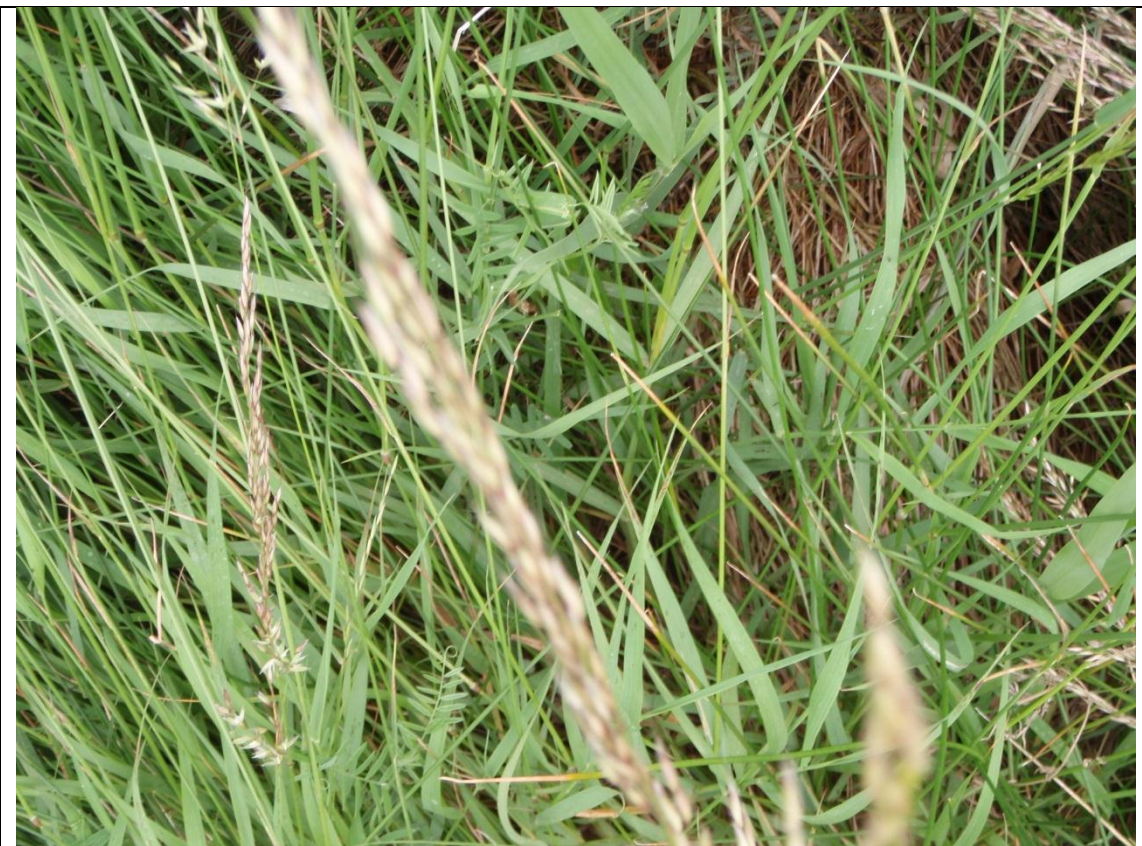
Plot code WF01

<p><b>Summary of records and events</b></p> <ul style="list-style-type: none"> <li>• Not available at time of reporting. Field evidence suggests that the plot vegetation has not been disturbed in 2011, but the sward is known to have been cut recently.</li> </ul>
<p><b>Relation to past and target conditions</b></p> <ul style="list-style-type: none"> <li>• This survey initiates the Vegetation Monitoring Programme and provides a baseline for assessing subsequent fen meadow vegetation development.</li> <li>• Vegetation characters suggest that the plot can be regarded as young, rushy fen meadow overstood by False Oat-grass but with the potential to stabilise and diversify through management.</li> </ul>

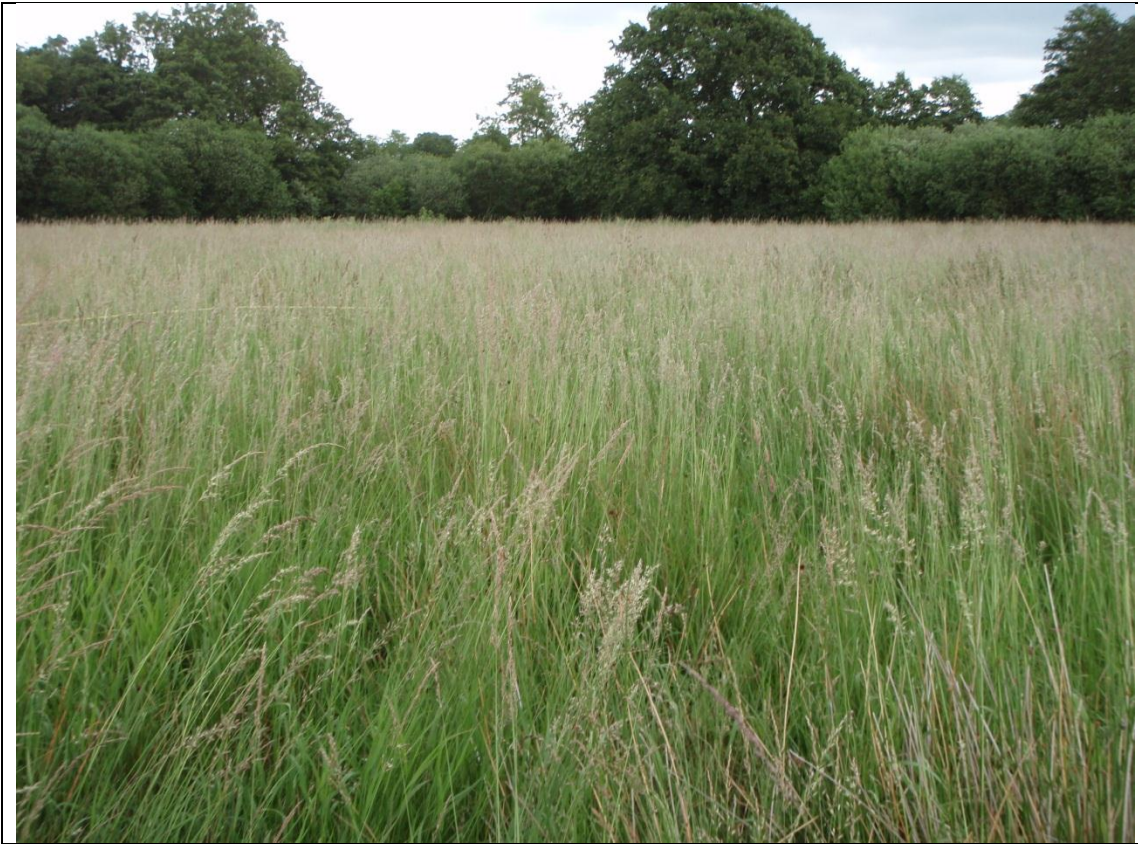
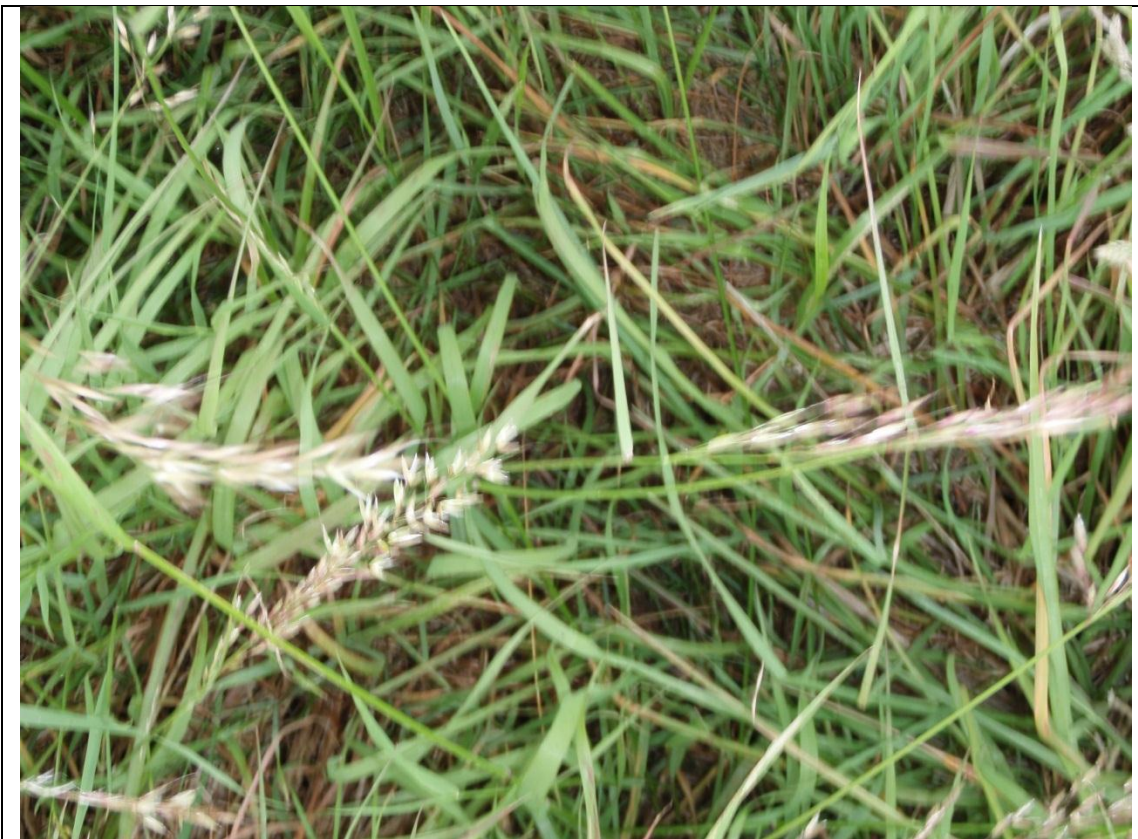
Plot code W02

<p><b>Summary of records and events</b></p> <ul style="list-style-type: none"> <li>• Not available at time of reporting. Field evidence suggests that the plot vegetation has not been disturbed in 2011, but the sward is known to have been cut recently.</li> </ul>
<p><b>Relation to past and target conditions</b></p> <ul style="list-style-type: none"> <li>• This survey initiates the Vegetation Monitoring Programme and provides a baseline for assessing subsequent Fen Meadow development.</li> <li>• The plot shows the area of transition between a species-poor Tussock Grassland, with occasional Fen-Meadow species, and the slightly more species-rich margin of the Fen Meadow stand. It is hoped that the vegetation will have the sensitivity to demonstrate the effect of restoration management.</li> </ul>
