Little Ouse Headwaters Project

Restoring the Little Ouse at Blo' Norton - October 2013

Part 1 What was done and why

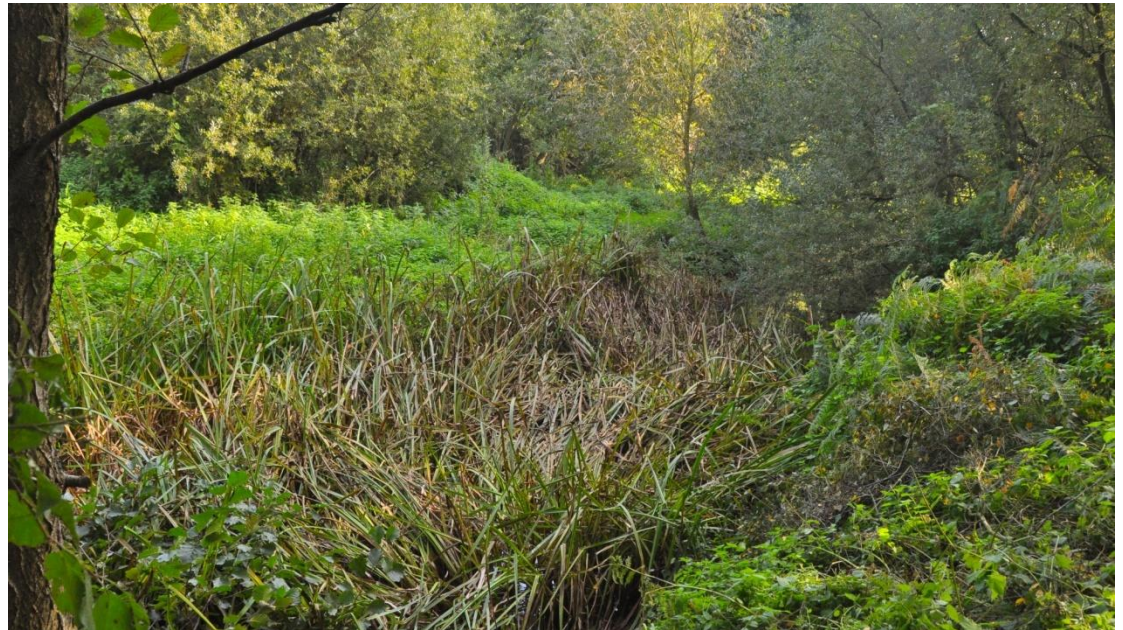
The Little Ouse - Autumn 2013

- Thick black mud (silt) along the whole bed of the river
- Full of reeds and sedge
- The water hardly flowing

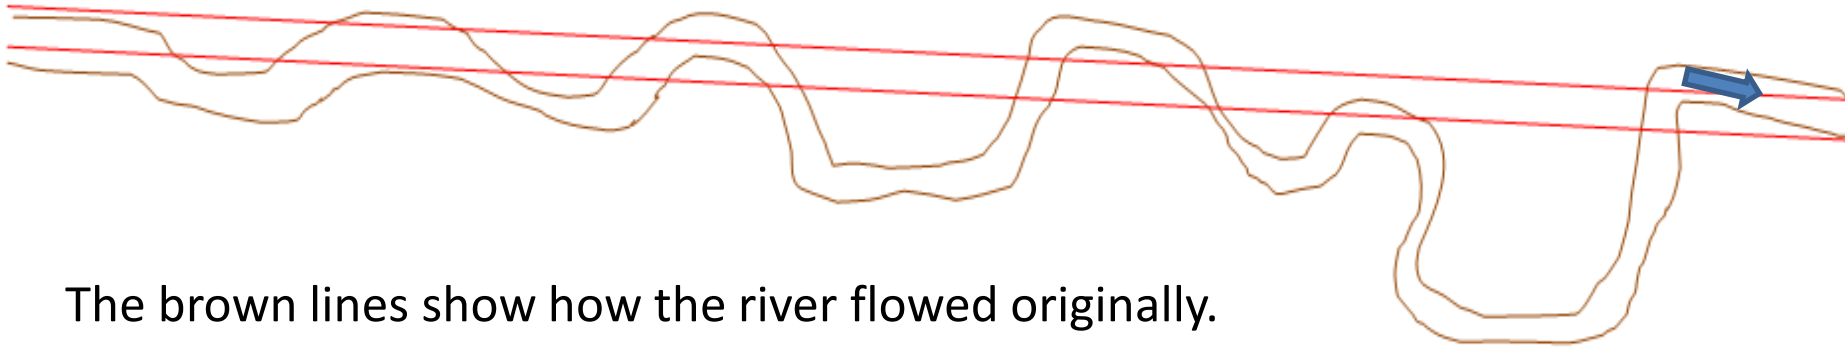
View from above

The brown lines show how the river flowed originally.
The red lines show how it had been changed by the start of the 1980s.

All the wiggles (meanders) had been straightened out.
This was to try to make the river work better as a drain.

They wanted to dry out the land and make it possible to grow crops.

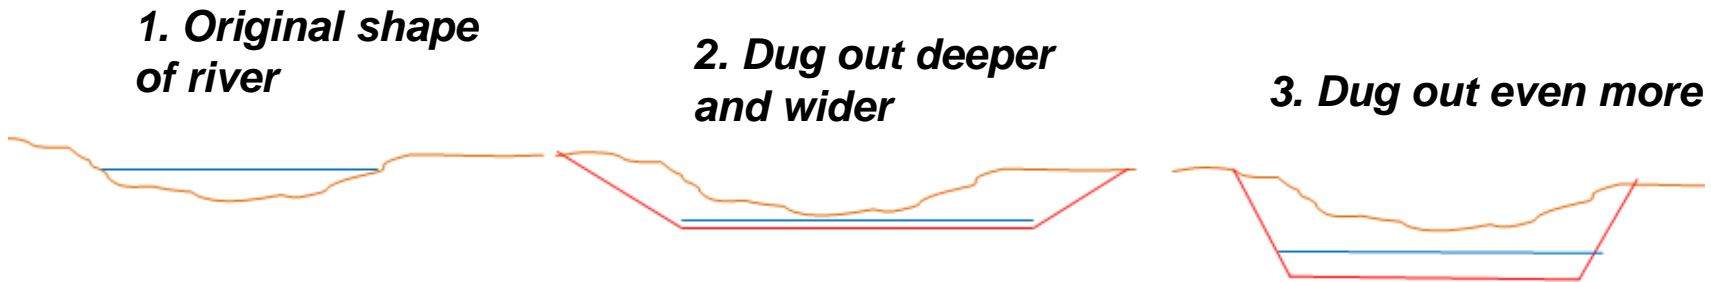
Three cross sections

The brown line shows the original bed of the river.

The red lines show how it was changed over the years.

It was dug out deeper and wider - and was made into the same shape all the way along.

This was also to try to make the river work better as a drain.

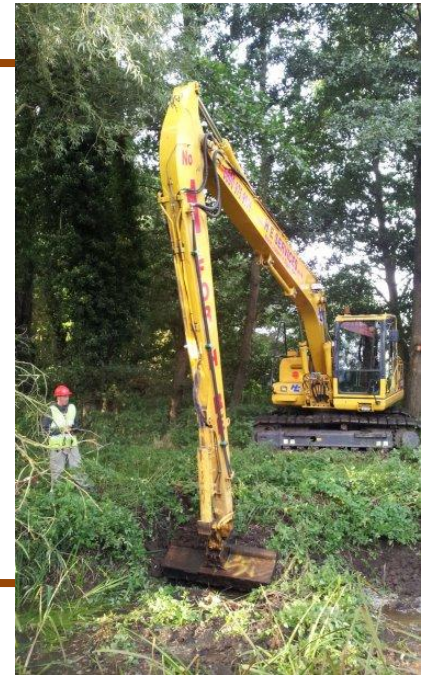
2) Typical cross section **AFTER**

- Mud and reeds moved to one side (sometimes to the left, sometimes to the right)
- Clear (and deeper and faster) water in just half the channel

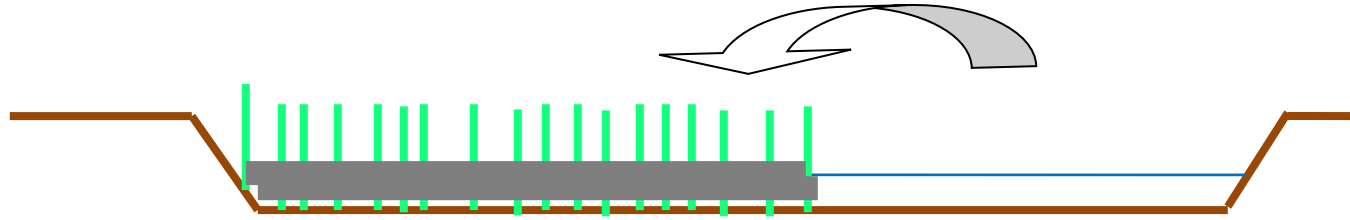
In summary. . .

The digger folded the mud and reeds from one side of the channel onto the other to make a narrower, clear channel.

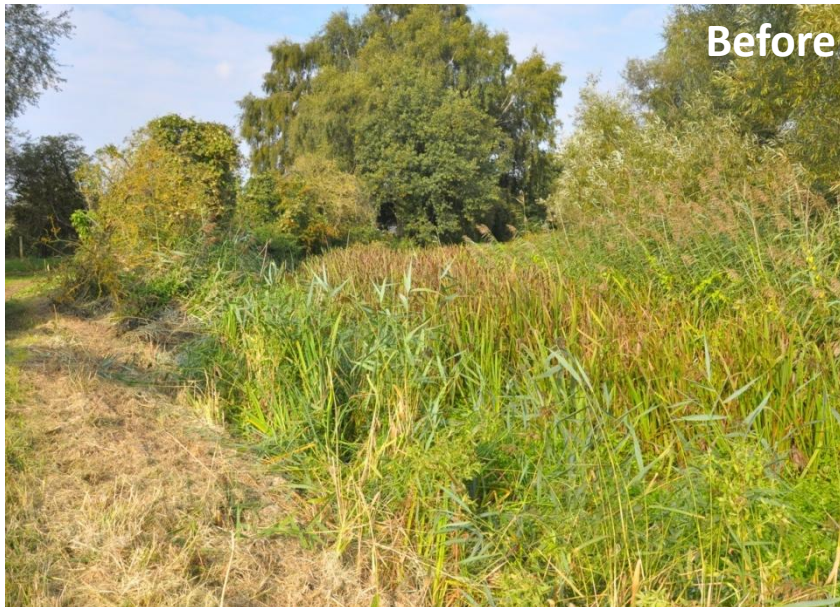
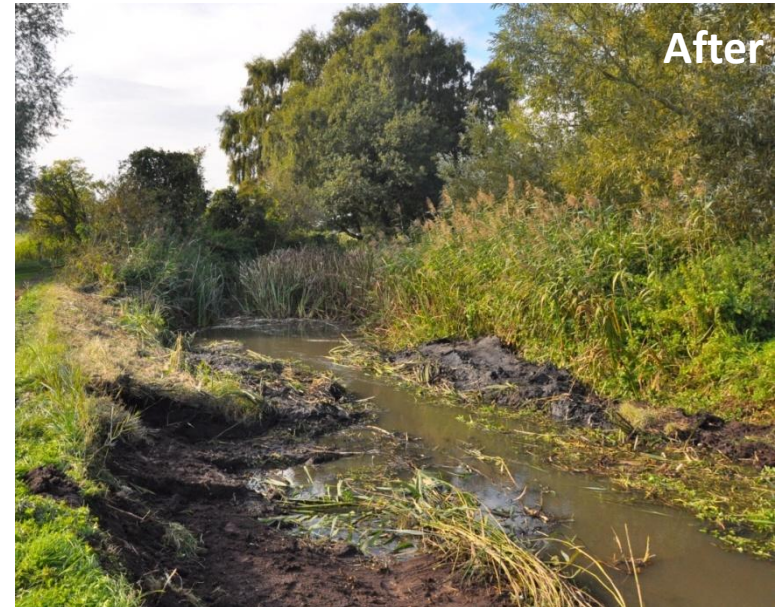
The new channel has bends in it - and pools

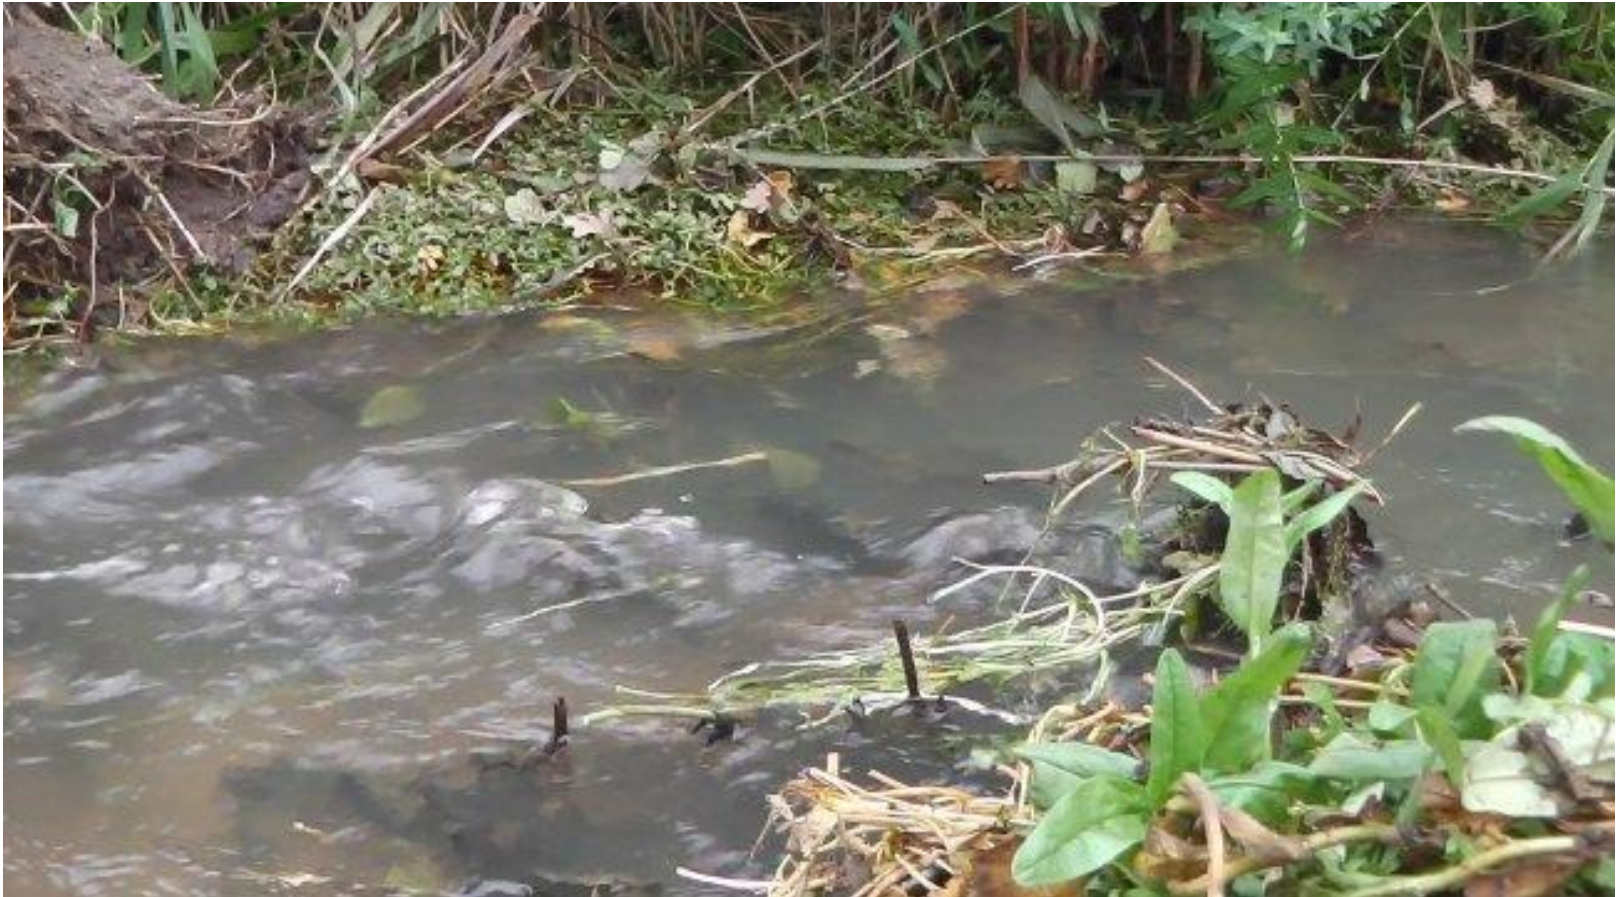
The river now has more energy

and moves much faster. This will help keep the channel clear.

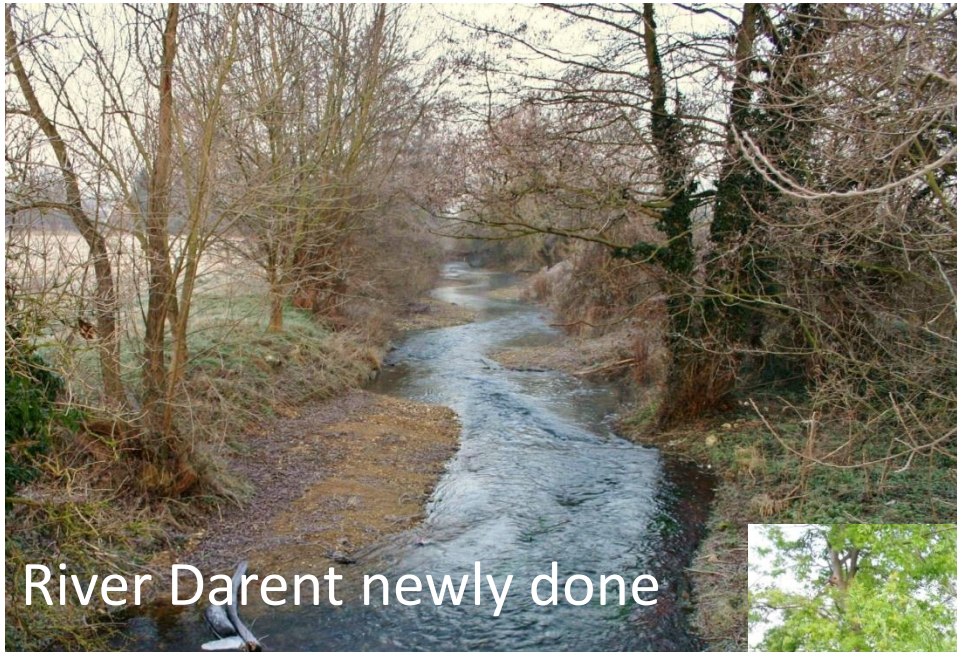
River Darent newly done

← Seven years ago Nigel and his team gave this river a wiggly channel with some shallow places and some deeper places.

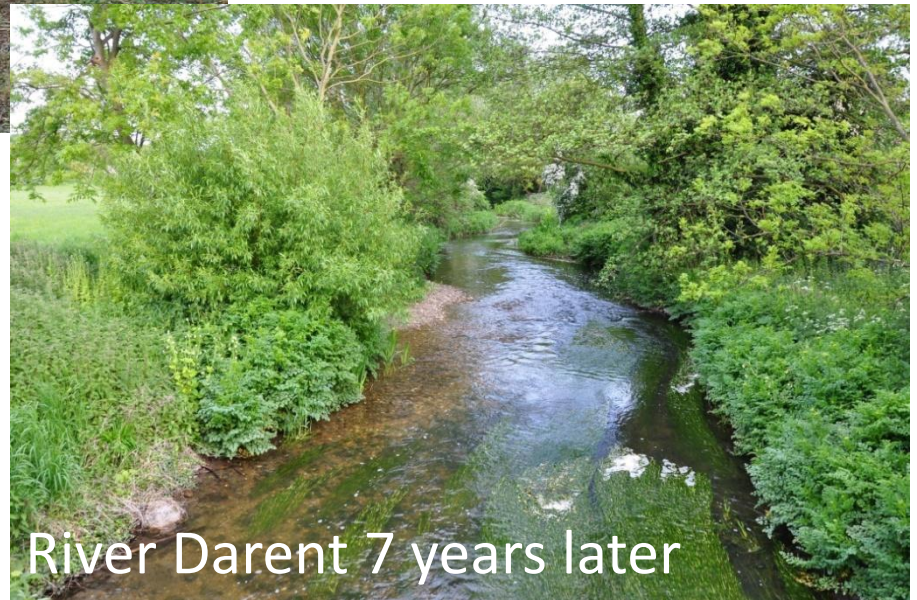
River Darent 7 years later

Seven years later it still → follows the wiggly route and has lots of energy to keep itself clear.
