LITTLE OUSE HEADWATERS PROJECT

DRAINAGE AND SOILS STUDY

ADAMS LAND MANAGEMENT LTD

May 2, 2014
Authored by: Andrew Adams

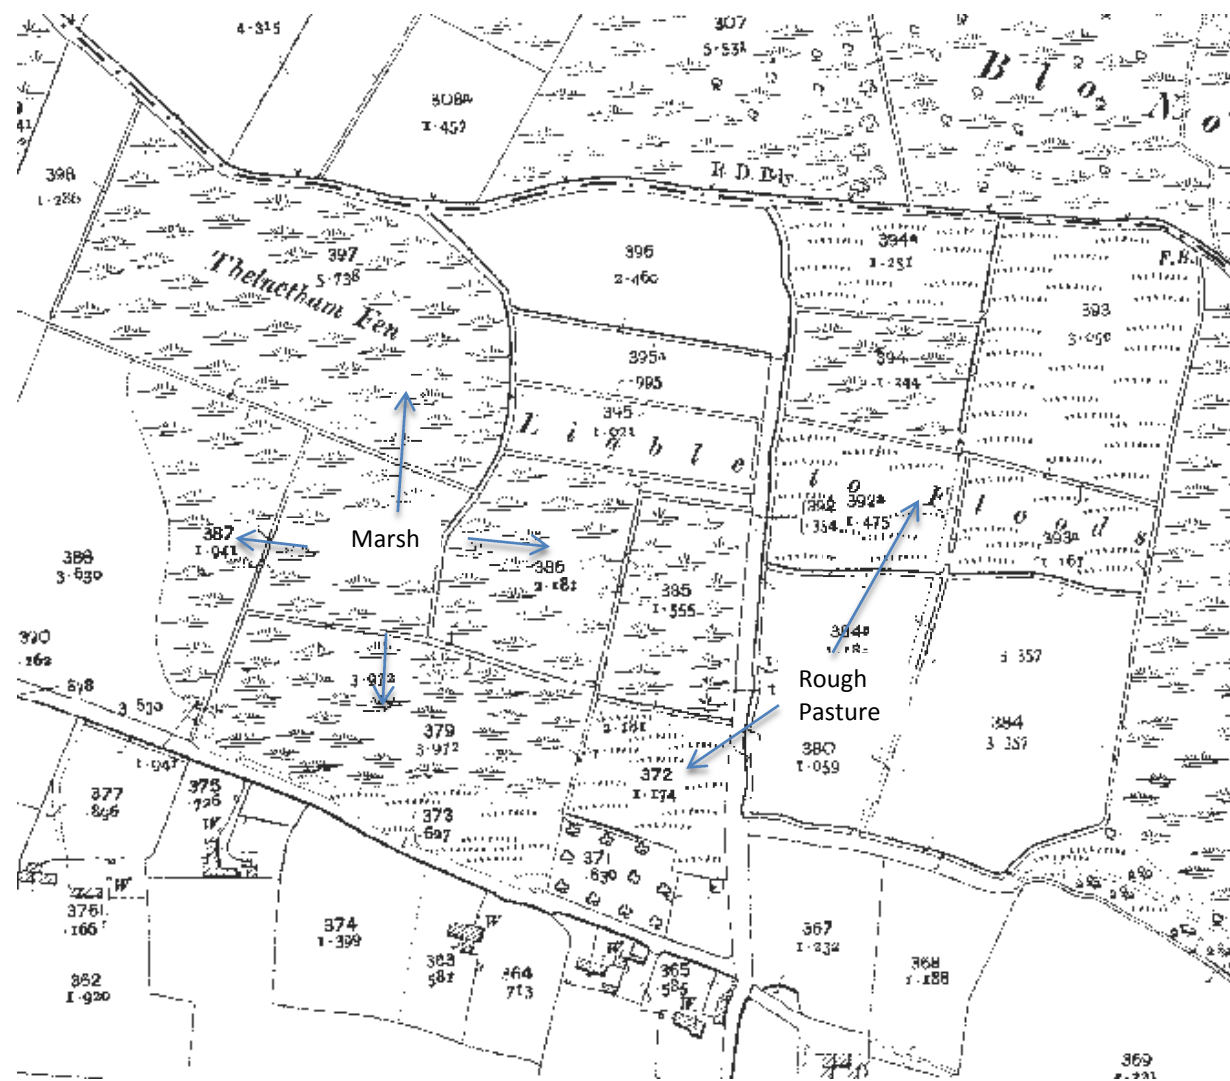
Extract from 1903/04 Ordnance Survey Plan – Land use marked

The 1904/05 map, extract below, shows a network of ditches within the fen area. The majority of the ditchers are shown as typical fen dykes or ditches at least 1 metre wide, based on Ordnance Survey mapping protocol. The ditches serve a drainage function and also a carrier function in the case of those running north to south and outfalling into the Little Ouse.

Land use was defined as marsh or rough grassland and although not specifically defined these definitions follow survey protocol and illustrate that a difference in land use was noted.

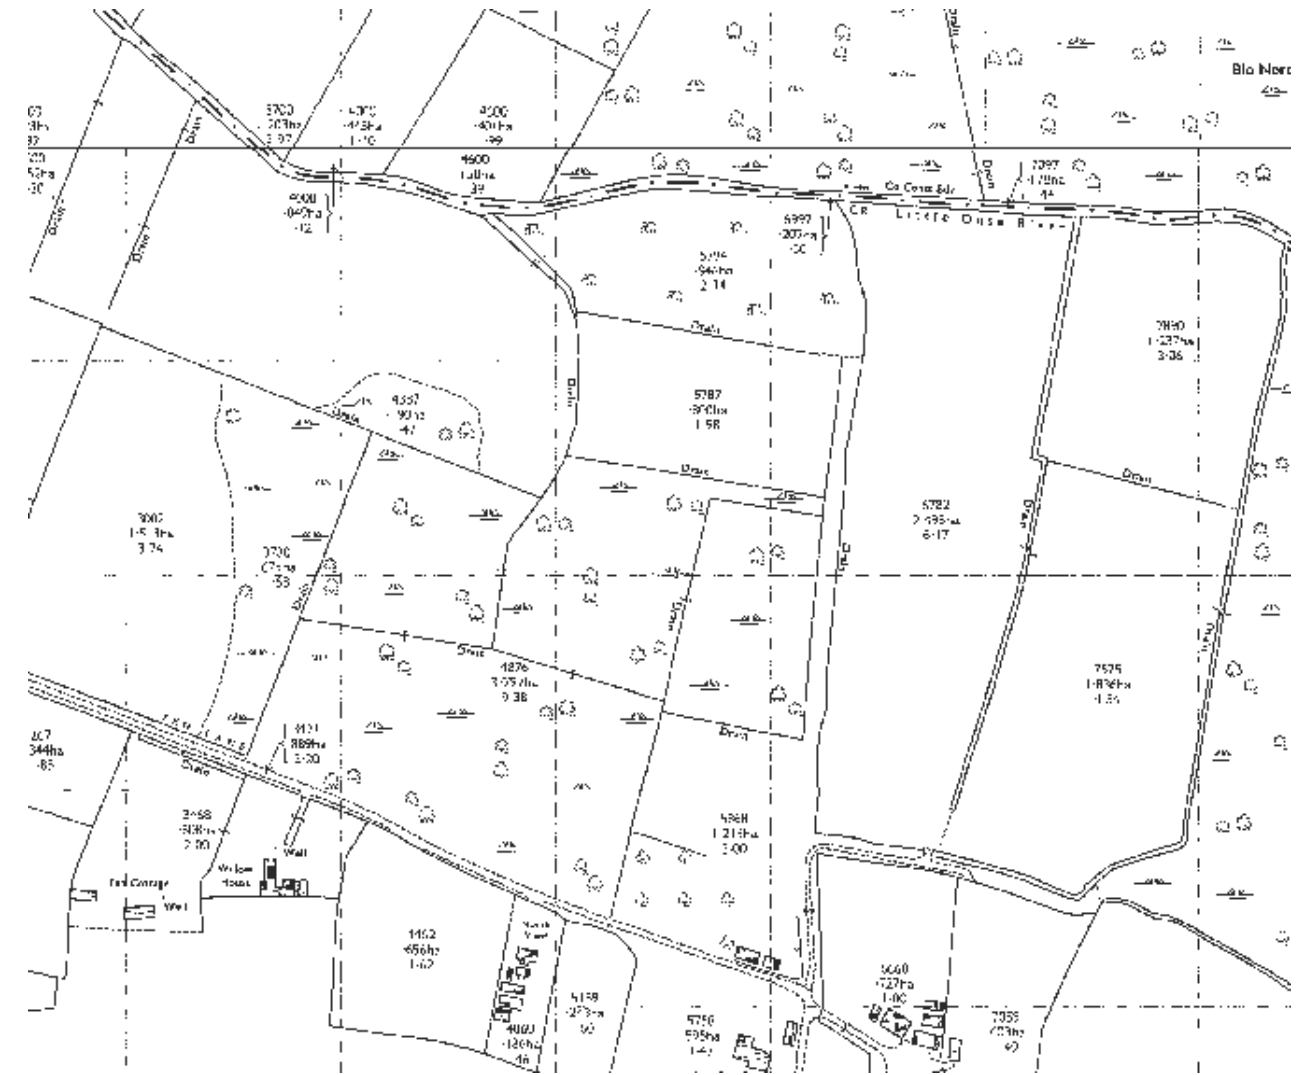
Extract from 1976/77 Ordnance Survey Plan

The 1976/77 map, extract below has a very similar layout of ditches, with very few having been removed despite attractive grant encouragement for field rationalisation and drainage prior to this date.
