LITTLE OUSE HEADWATERS: PILOT RESTORATION PROJECT (AS BUILT REPORT)

October 2013

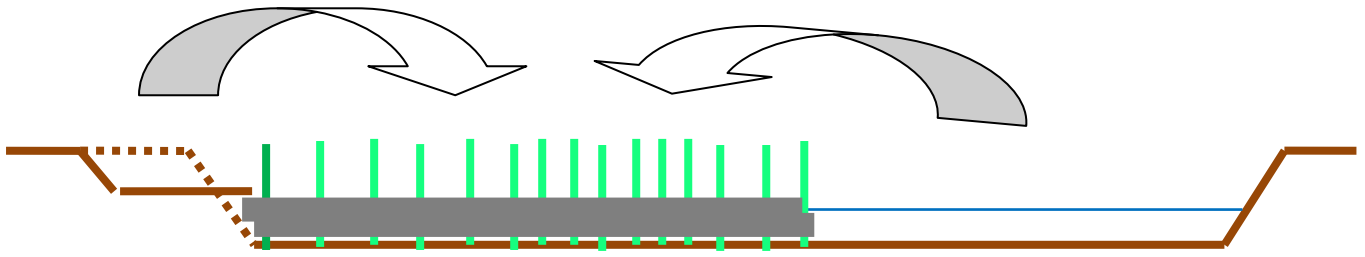
E1. Channel reed and silt re-distribution combined with bank re-profiling to create wider wetland reed shelf and provide more material to make formation of low-flow channel more self-cleansing in the future.

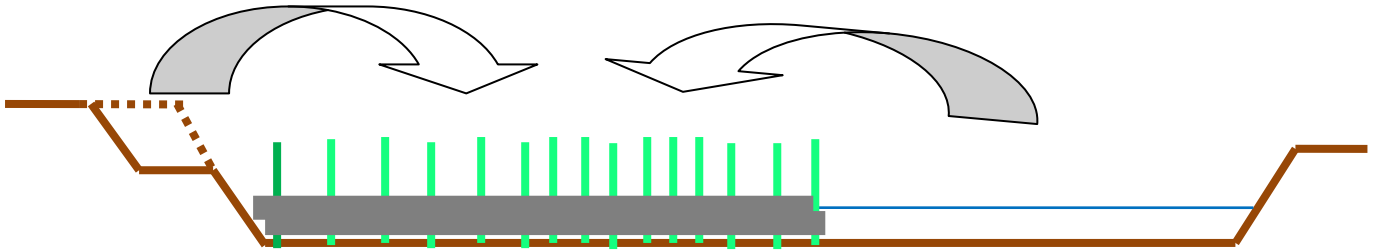
E2. Channel reed and silt re-distribution combined with bank re-profiling to make formation of low-flow channel more self-cleansing on the right – only done in top 200m where banks very high.

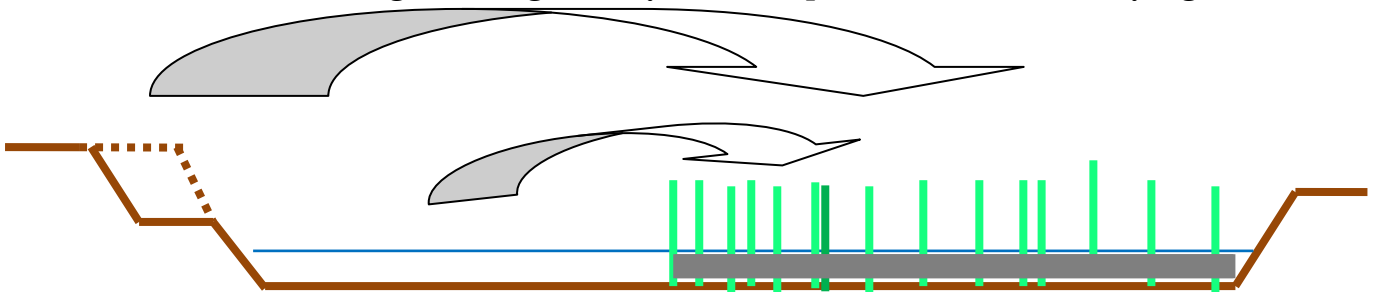
E3. Channel reed and silt re-distribution combined with bank re-profiling to make formation of low-flow channel more self-cleansing on the left – only done in top 200m where banks very high.

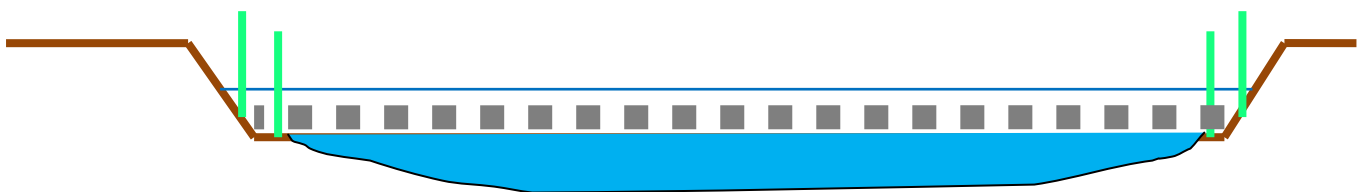
F1. Creation of pool with banks left untouched

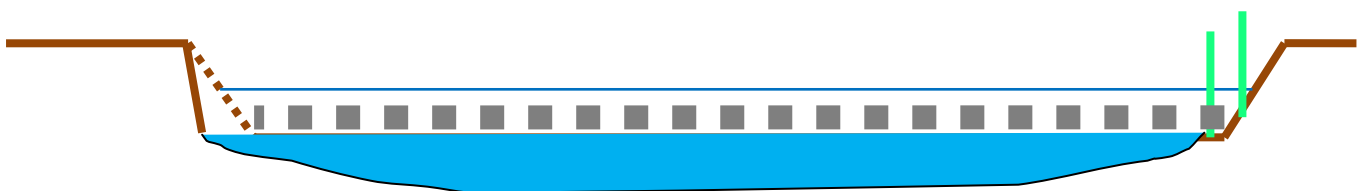
F2. Creation of pool with left bank made steeper and more suitable for water voles to burrow into
