# **Recording of the Monitoring Plots,**

# Scarfe Meadows, 2020

Mike Harding on behalf of Little Ouse Headwaters Project

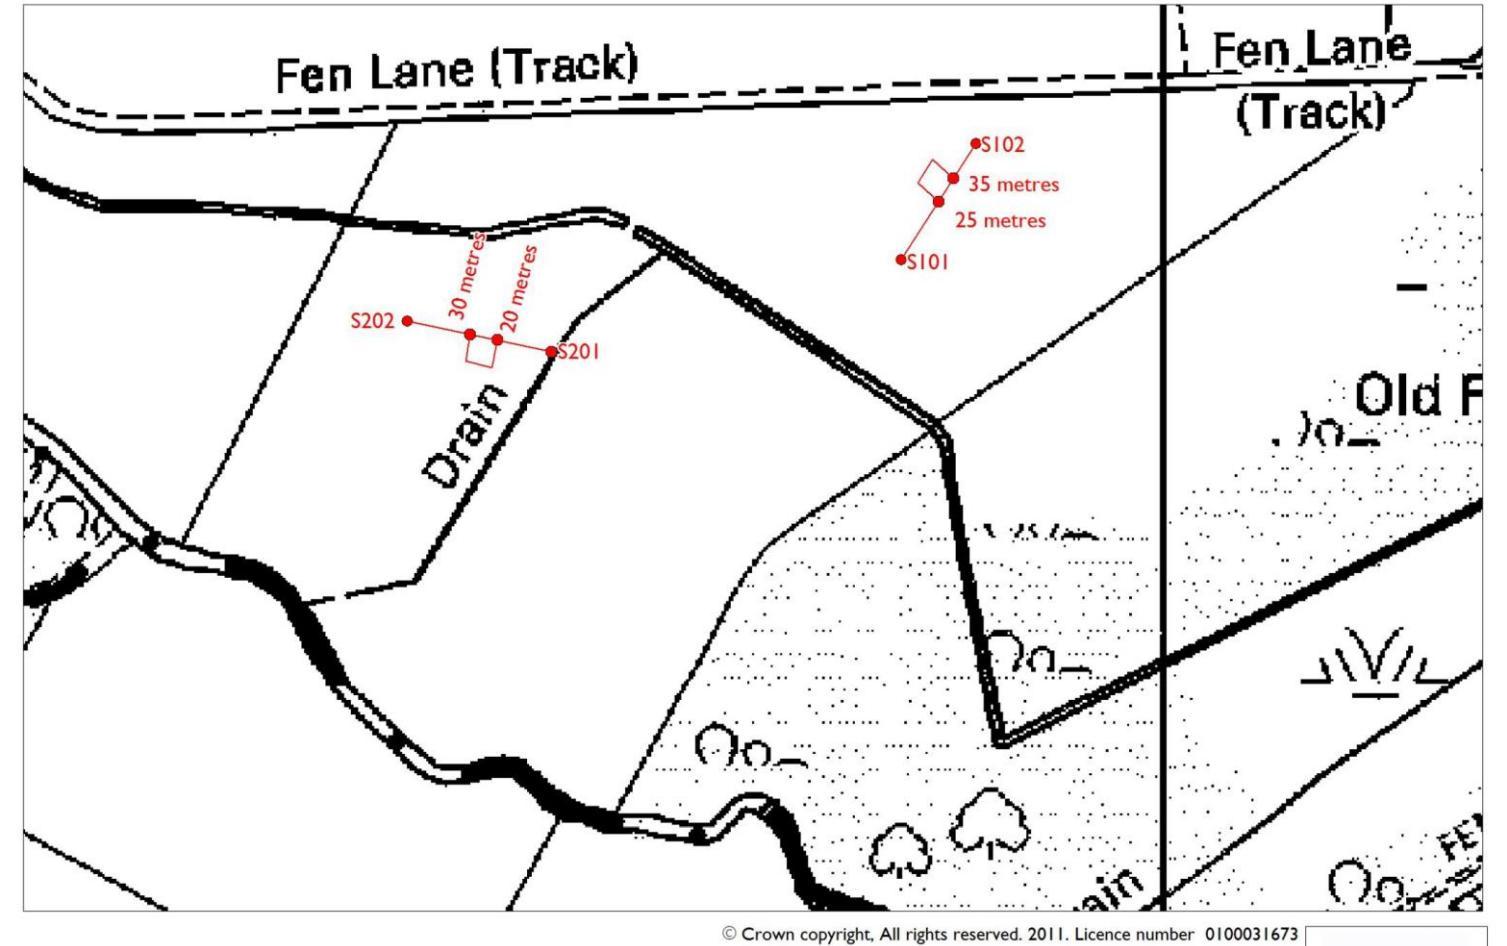
# Figure 1: Location of Plots. Reproduced from OHES (2011)

Plot and marker details are given in OHES (2011), reproduced in Table 2 and Figure 1. Note that at the time of the 2020 resurvey none of the marker posts were still in place. The posts

VEGETATION	PLOT	MARKER	Marker Post	EASTING	NORTHING	Plot location	
ТҮРЕ	CODE	POSTS	Location			(see Figure 4)	
Wet Grassland	S01	S01-01	Freestanding near southern margin of Wet Grassland	99901	80819	Southern corner 25 metres northwest of S01-01; plot on northwest	
		S01-02	Freestanding near valley margin in line with Poplar tree.	99928	80861	Side	
Flood Pasture	S02	S2-01	On fence line on eastern side of western field	99775	80786	Northeast corner of plot at 20 metres west of S2-01; plot on southern side.	
		S02-02	Freestanding within MG9a grassland	99723	80797

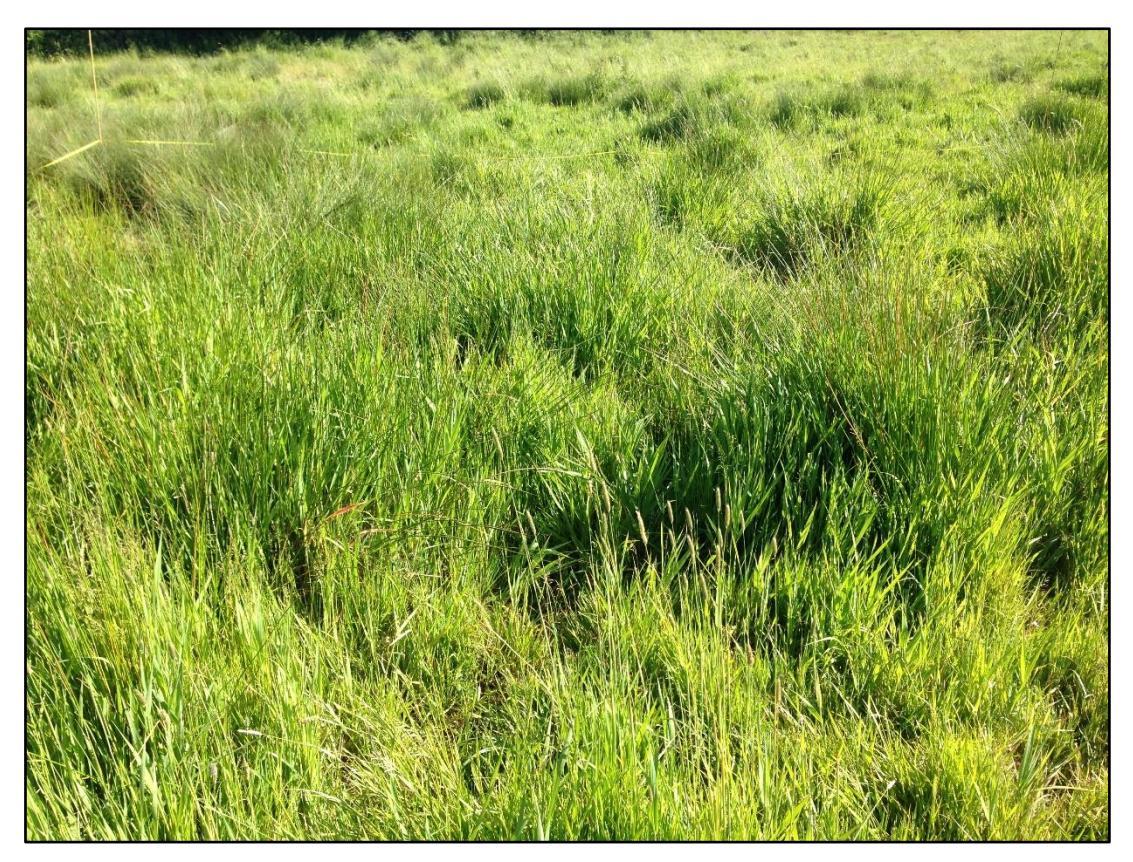
S01 Wet Grassland. View taken from the centre of the southern edge of the plot looking north. TL 99910 80842, 29 05 20.

Overall flat but uneven with poached areas and much tussock giving reasonable micro-topographic variation. Silty soil surface.

This is a relatively flat area of marsh on silty clay soil, but with considerable microtopographical variation attributable to tussocky vegetation and localised trampling and poaching. There is an upper tier of rushes, particularly tussocks of *Juncus effusus*, and more locally, *J. inflexus*, and then a tier of shorter grazed vegetation, perhaps maintained lower by grazing. Within the grassy matrix there is a third discontinuous layer of herbs of short grasses and rushes, and then the ground which due to grazing has variable amount of bare ground and surface litter. Bryophytes are generally absent. The plot was much dryer in the 2020 monitoring period, recording no water at the surface, whereas in 2011, there was significant water a few cm deep and the plot generally saturated.

The plot is progressing as expected in terms of vegetation development but is too dry to sustain wader interest, the core objective for the site. The incursion of creeping thistle, perhaps related to recent dry summers, is also a cause for concern.

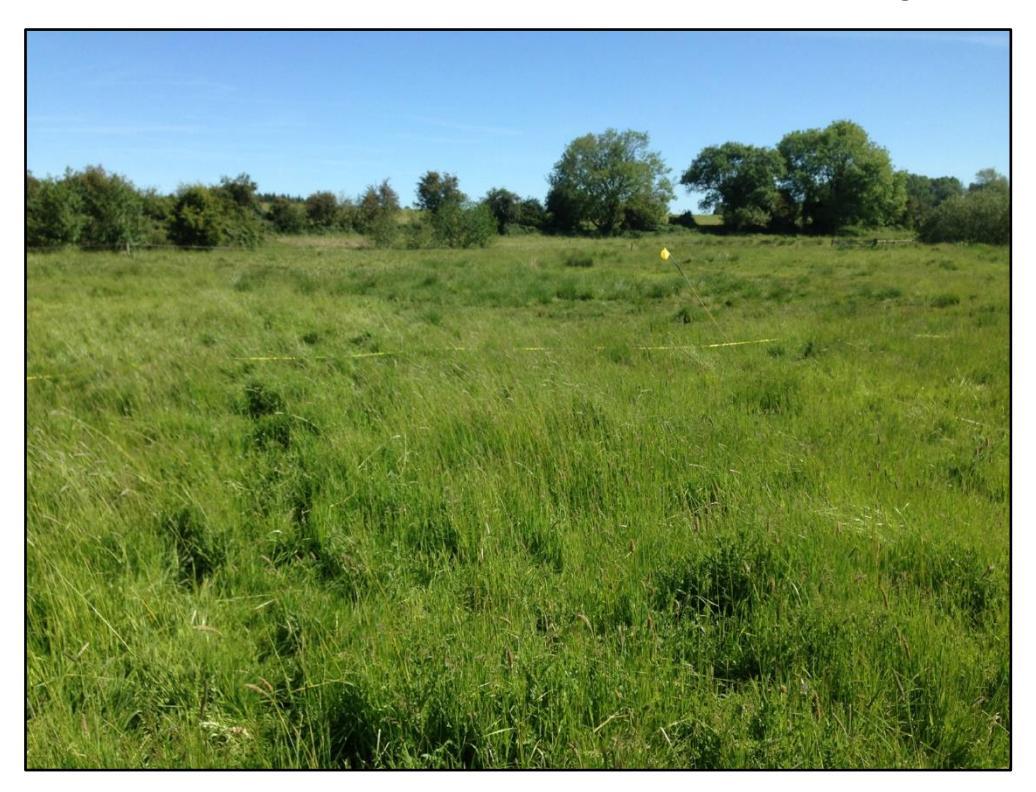
S02: Flood Pasture Grassland View, taken from TL 99746 80780 looking north

Very flat silty clay surface, very little micro-topographical variation. No tussocky structure, even meadow sward.

The plot is very flat with very little micro-topographic variation, not even afforded by vegetation tussocks. The substrate was silty clay soils. There was significant plant litter, around 76% and 3cm thick on average, a significant increase from 2011. Trampling was modest, and had decreased from 2011, with much less bare ground – 12.5% in 2020 compared with 55% in 2011. These changes *may* reflect the fact that there had been three weeks more grazing in 2011. Structurally, this remains a grass sward with no rushes and no tall reed-like grasses as recorded in Plot S01. A tall and rather dense canopy of narrow-bladed grasses dominates the sward, with very few broad-leaved herbs other than creeping thistle and no bryophytes on the ground. This has provided very little structural variation.

The site has not changed significantly and is rather dense and species poor, lacking true wet grassland indicators. The issue is not management – the sward is appropriately grazed – but water levels. The site remains too dry to meet target conditions. The increase in creeping thistle is also a concern.
